RECONSTITUTED BLACK REPORT

Collision Synopsis

Vehicle Examination

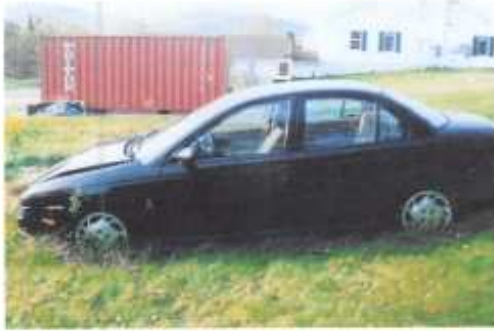
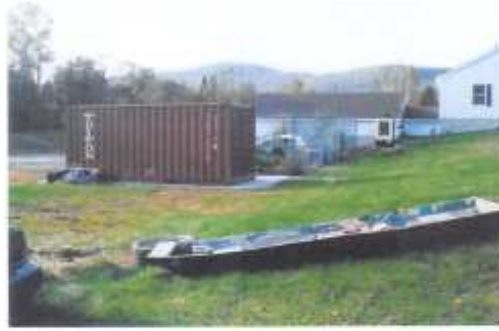
Possibly 2007 photographs based on computer file property

The Saturn apparently had been moved over the years from its location out in the far field as shown in the photograph below to a location adjacent to a storage bin. As shows in the photographs below, there is cross transfer of evidence pertaining to a dirt imprint on the passenger's front tire. The cross transfer would have developed when the Saturn was at rest in the field over an extended period of time before being moved. Simply moving the Saturn, now developed further damage to the front bumper which was evident.

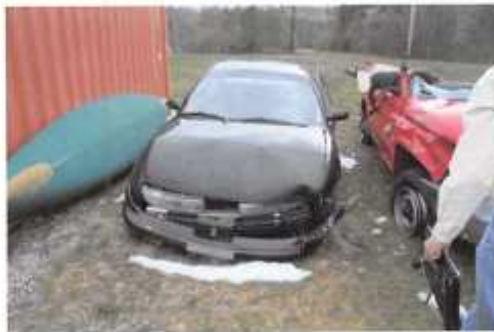
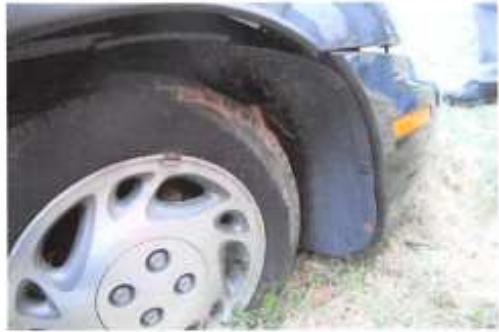
May 1, 2010 during vehicle inspection

On examination of the Saturn in 2010, the general vehicle was in poor condition exclusive of the damage sustained as a result of a collision. It appeared to be in a far better state back in 2007 as shows in photographs.

The deterioration would more likely than not be a result of weather over the years and/or moving the vehicle throughout the back field of the NHSP barracks, The Saturn was not in a secured, sheltered environment. The vehicle had passed a yearly safety inspection evident by an inspection sticker affixed to the front windshield, expiring in October 2004 and had

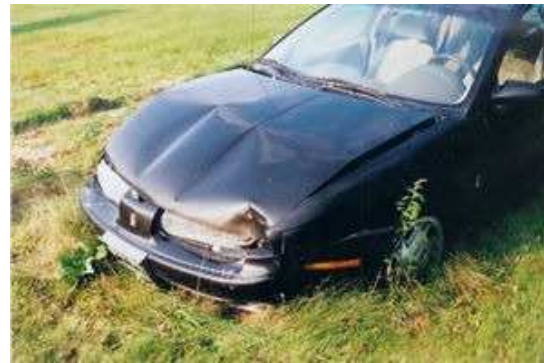
2007 Based on computer file property

As depicted in photographs dating back to ≈ 2007, the front bumper is observed still in place as it relates to the damage it had originally obtained. However, during our inspection, the front bumper cover was displaced with the driver's side portion in contact with the ground. The inner 'honeycomb' core was also now exposed. It was apparent that someone or something had disrupted and/or removed the center fasteners of the outer bumper skin; exposing the inner core. It is unknown as to when and or how this action occurred.

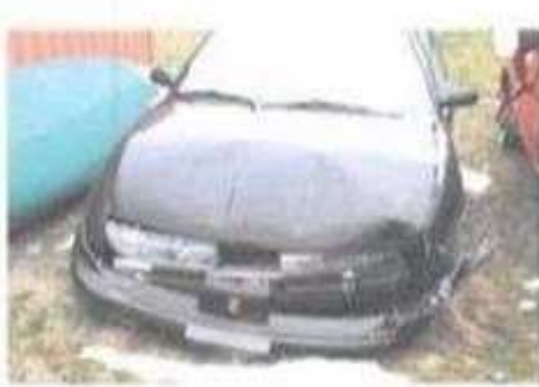
May 1, 2010 During Vehicle Inspection

***Center bumper cover fasteners removed
Red arrows depict origin***

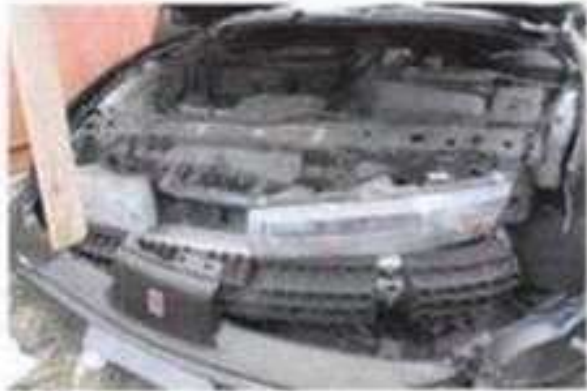
Displaced Driver's Side Core

The driver's sub inner core was pushed somewhat inward as compared to the passenger's side. The core also showed lithe damage with a few of the core vents slightly bent. There was also evidence of some abrasion to their outer façade. The mechanism which caused the bending to the core vents cannot be positively be classified as having solely occurred at the locus, as the Saturn has been moved at least once in the field behind the barracks. It is unknown as to whether the moving of the Saturn has caused additional damage to the inner core.

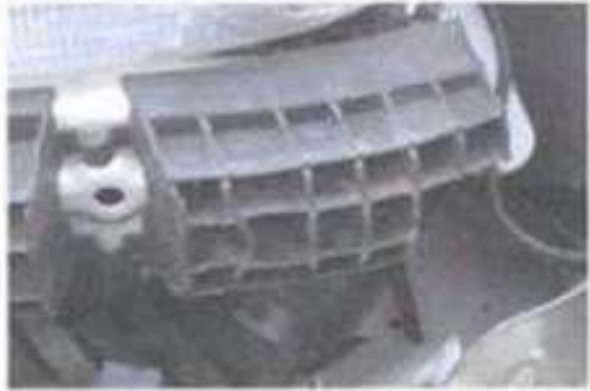
Damaged Core Fins

If the displacement of the core and the damage to the fins was the result of the initial impact in 2004, the intruding object would now need to extend down across the front bumper. However the façade of the intruding object could not have a perfectly vertical façade as it relates to the Saturn's approach. The core is still not pushed back to the extent of the hood damage to justify a perfectly vertical façade, nor does the hood dent have a perfectly vertical appearance, but rather an acute angled indent.

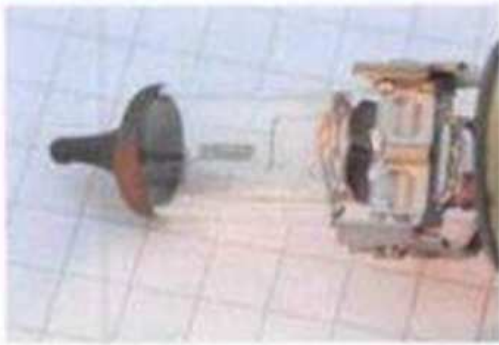
*Low Beam, Driver's Side (off)
Undamaged filament*

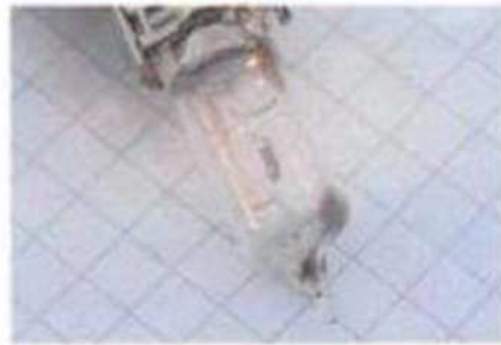
If any of the exterior lamp filaments were incandescent (illuminating) at the time of the collision, the filament(s) would have elongated and uncoiled as a result of being ductile. Inertia of the filament(s) during a collision causes this to occur resulting in what is described as 'hot shock'. As depicted in the photographs which illustrate the damage to the Saturn, the majority of the dynamic collapse is in the area of the corner marker light and headlight assembly. An examination of the headlight bulbs revealed the high beams were on at the time of this impact. The filament showed classic evident of elongation while the low beam maintained its original coil. This is of important as it relates to the illuminated visual field ahead of the operator at the time of any or all impacts.

*High Beam, Driver's Side (on) Incandescent
Elongated filament*

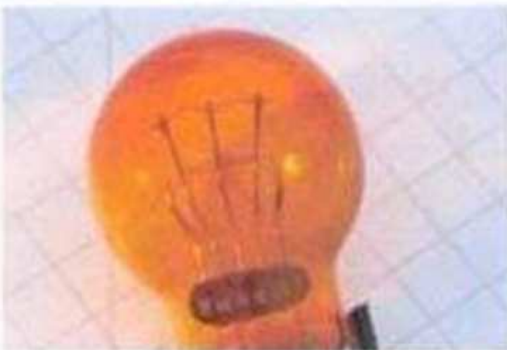
The front amber corner bulbs contained both marker and turn signal filaments and were not of the same make. The marker filament showed signs of elongation under low magnification. This elongation is consistent with the filament being incandescent at the time of the collision. Both turn signal filament maintained their original culled appearance, rendering their status as being inconclusive.

*Driver's Side Amber lamp
Elongated marker filament*

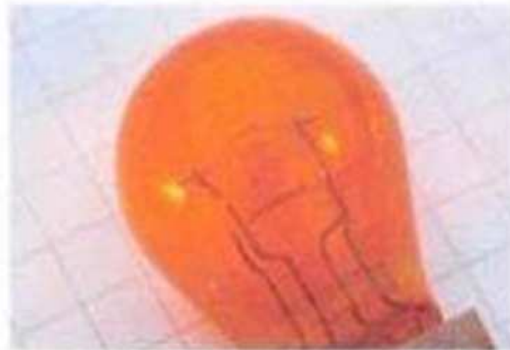
*Passenger's Side Amber Lamp
Elongated marker filament*

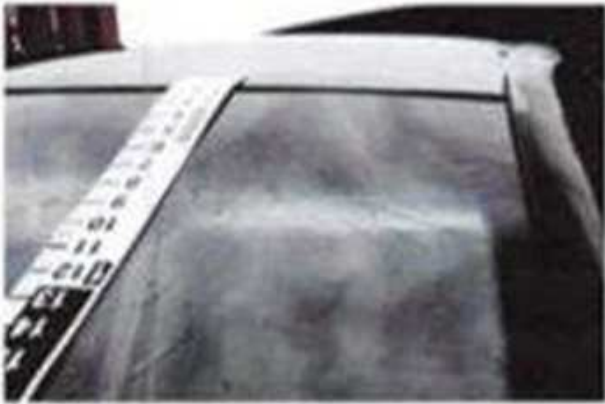
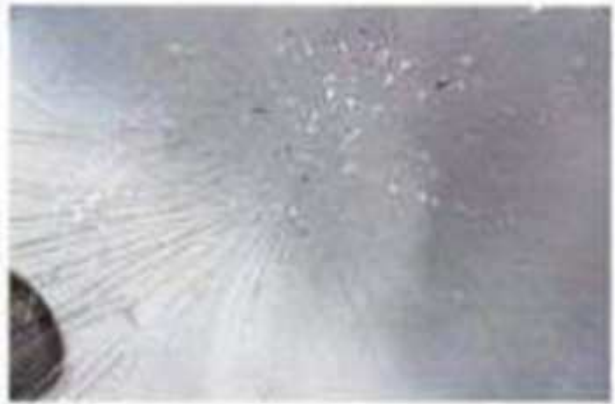
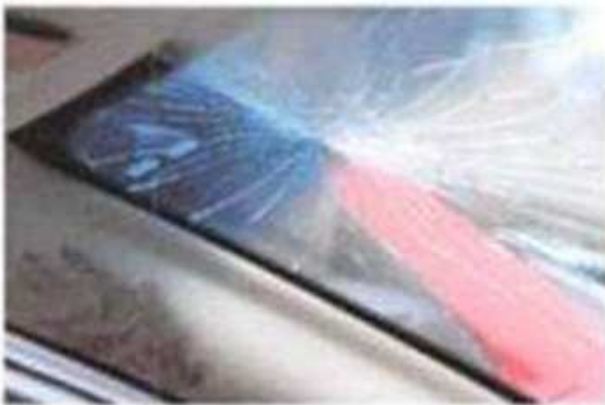
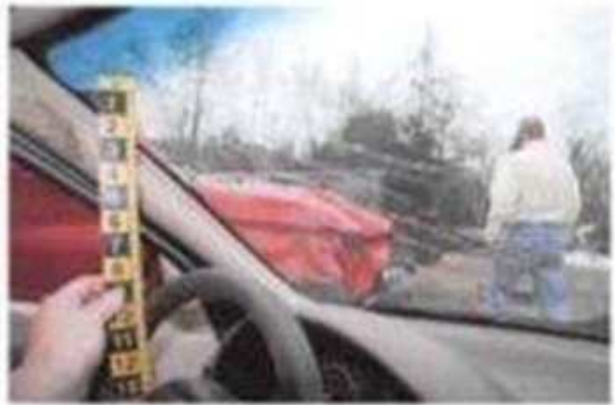
A small circular (stellar) pattern impact to the windshield was located ≈ 8 inches above the crest of the steering wheel. The interior portion of the pattern did not have any course feeling when touched by the palm of a hand. The exterior portion of the windshield did have cutting edges along each fracture. There was also a small indentation to the stellar pattern on the inside; rendering the fracture as having occurred from the interior by an unknown object. The placement of the stellar impact is slightly lateral of the driver's seated position and towards the driver's side 'A' pillar post. The stellar impact is also vertically located ≈ 5 to 6 inches down from the top section of the windshield and within the tinted area as assigned by the ASI level.

There are at least four if not more possibilities as to how this fracture occurred. First, during airbag deployment when the bag inflates and makes contact with the windshield, however, the airbag fabric had been removed and any attempt to rule out this possibility has been compromised. Further discussion regarding the airbag status will be forthcoming.

Secondly by means of the operator striking their head on the windshield during an impact. There was no evidence of any hair fibers and/or root within the break. The fracture to the glass was clean with no foreign material and appeared too small as compared to a typical head strike.

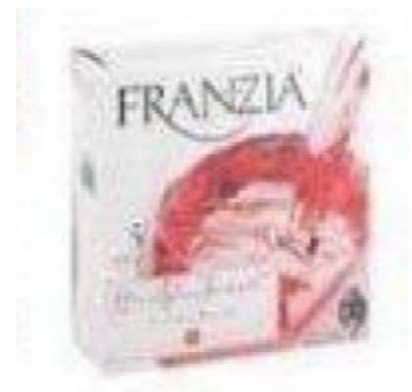
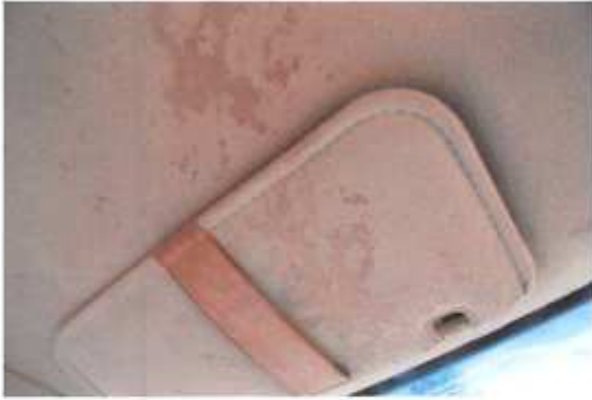
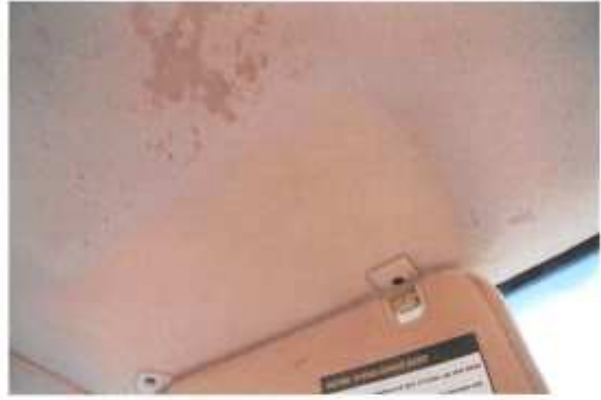
With this said, the interior roof line was stained with a reddish appearance which was in an area forward and above the driver's position. According to the police report, they classified this as a red liquid and reference a box of Franzia Wine within the vehicle. The box of wine would have appeared similar to the exemplar one shown to the right. As aforementioned, the visor was believed to have been in a position folded against the roof. As shown in the photographs below, the area behind the visor when in a lowered position is clean of any liquid aspersion.

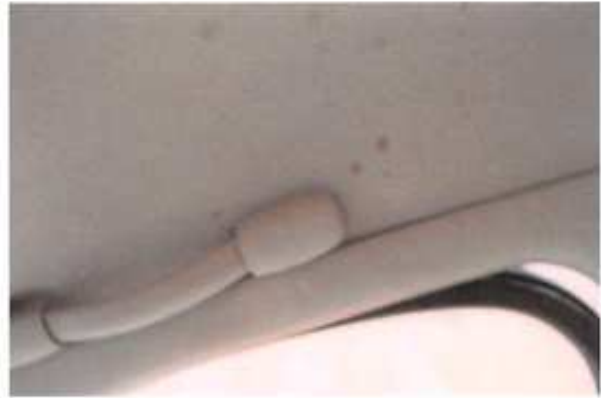
The aspersion then appears to have been projected or sprayed across the roof line towards the passenger's side. The spattered did not have the classic signs of an elongated nature to the naked eye as associated with blood and did not contain the classic tail. However, this does not rule out the possibility that the aspersion was not of a biological nature without a proper analysis.

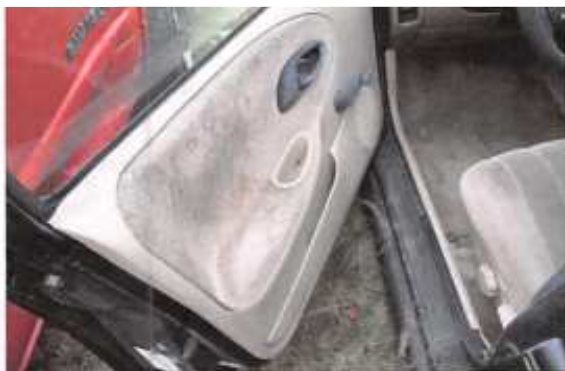
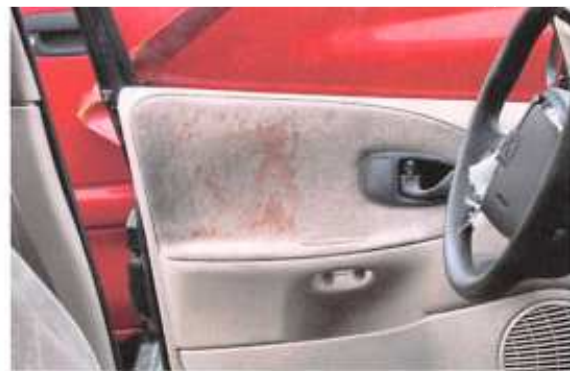
Another area containing the same type of stain was located on the driver's door panel. This area was heavily saturated and had a downward type spray. What was interesting about this area was it mainly was positioned on the aft section of the door panel with almost a vertical boarder going down the right side just aft of the interior handle. There was also no liquid aspersion on the driver's seat.

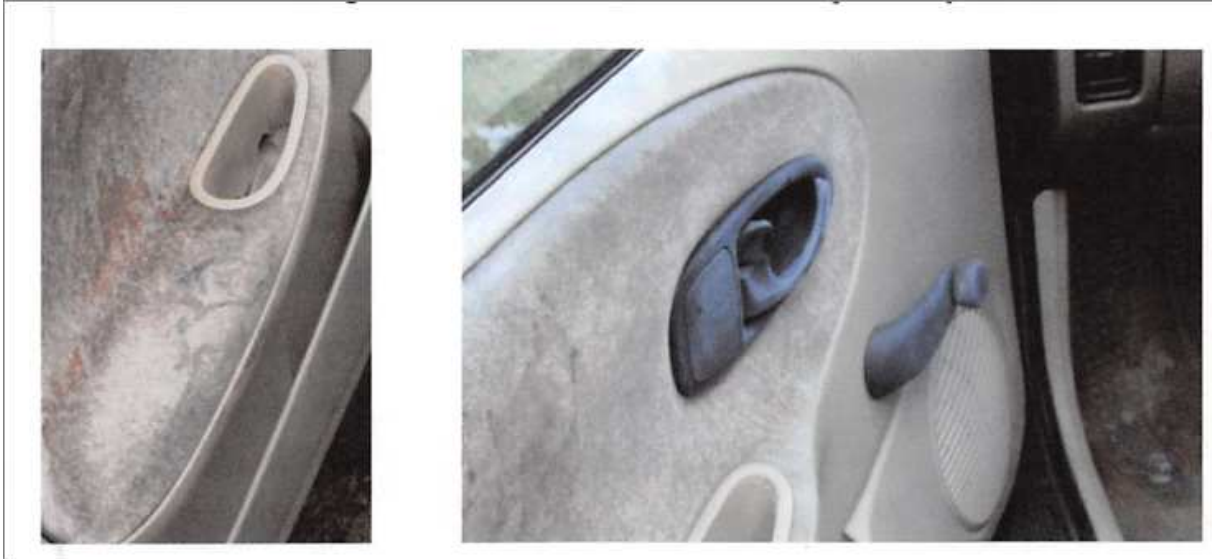
As it relates to the driver's door panel, a blackish print pattern was located on the arm rest. The print was aft of the door handle cup and wrapped slightly along the right edge. It is unknown at this point what if anything had developed this mark. Both the interior door handle and window crank had a whitish appearance; similar to the chemicals used to dust the vehicle for forensic prints. The foreign chemical could also have been deposited by the airbag during deployment. Given the extended period of time this vehicle has been sitting in the environment, it could not be positively identified.

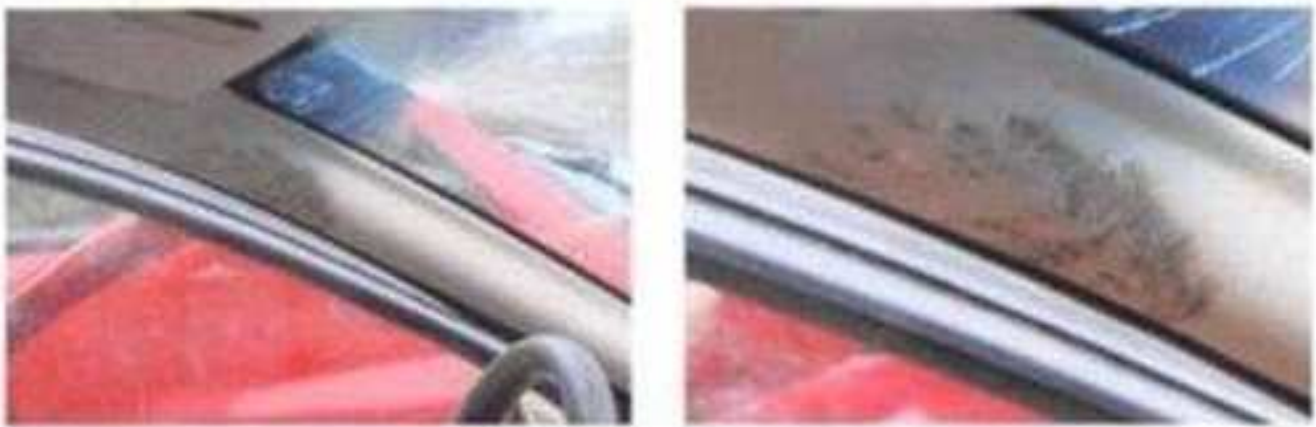
On the 'A' pillar post and adjacent to the stellar break to the windshield, a brown or blackish type smear is evident which almost has the same visual color as the print on the driver's door interior arms rest. To the naked eye, it gives the basic impression of possibly a left hand print versus a right with three extended digits pointing towards the roofline. However, again, a specialized technical examination of this mark would need to be conducted by other persons.

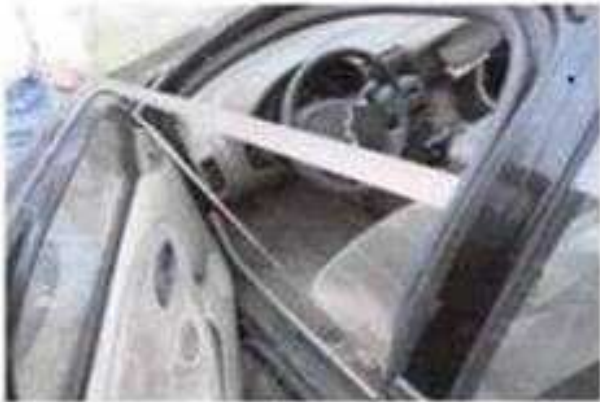
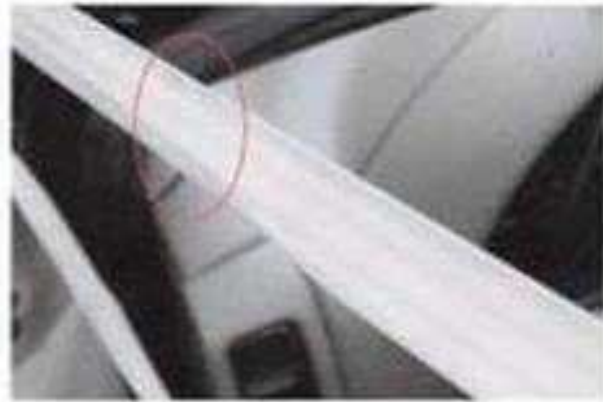
The seatbelts were of an active restraint system. The driver's belt did not show any signs of stress concentration marks, webbing elongation, deposits of foreign matter, and/or belt stiffening which would indicate the belt was worn at the time of impact. The SDM download also indicated the driver was 'unbelted' at the time of the collision. There was no reddish liquid aspersions consistent with what was located on the interior panels. The belt was warped in one location; consistent with hanging from the 'D' ring on the 'B' pillar post above the operator's head. This would be common for belts that were in the unsecured position over a period of time.

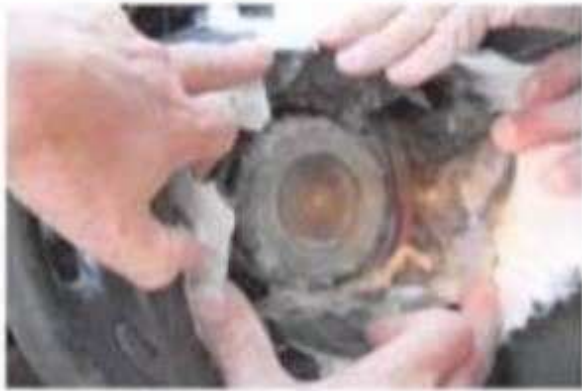
Driver's Side airbag actuator

The fabric airbags themselves were cut at the base and removed from the vehicle as shown in the photographs above by unknown persons. This may have been for the reason of examination by laboratory personnel. In doing so, evidence of any contact with one or both airbags by either the operator and/or any person seated in the passenger's seat can be analyzed by authorities. These airbags did deploy within a period of time relative to the situation at hand.

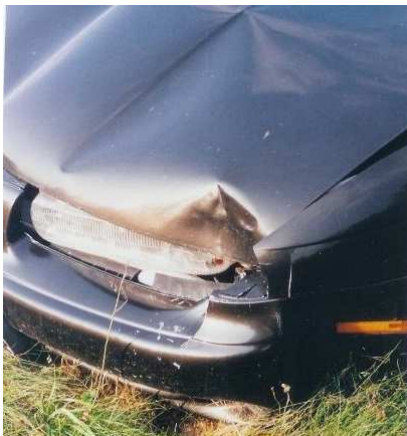
Photograph from 2007

There were \approx three areas of contact to the front of the Saturn. The first one which contained more significant damage than the other two was a frontal impact to the driver's front corner. It should be noted; at the time of our investigation, the Saturn had been moved throughout the back field of the barracks. The front bumper was now hanging off the vehicle and not in the same condition as depicted in photographs taken in the year 2007, it is unknown what type of damage was associated with the vehicle back in 2004. However, the actual structural damage to the hood was consistent and unchanged.

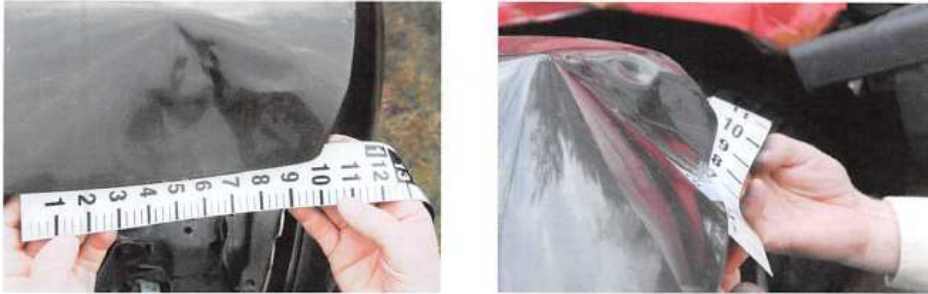
On close examination of the hood damage, the width was ≈ 7 inches with a maximum depth of ≈ 9 inches. The overall height was ≈ 4 inches and angled at ≈ 45 degrees off perpendicular. There was no fracture of the paint or foreign material embedded. The overall damage was not smooth but rather uneven and did not contain the classic geometrical shape of a tree's outer façade.

The entire hood was however pushed back ≈ 2 inches and buckled in the middle due to impact. This also resulted in the radiator upper support being bent and the headlight assembly displaced backwards. However, the aforementioned bumper and inner core were not pushed back to the same extent. If they were pushed back to have a perfectly vertical inline damage with the hood, the front bumper and core would need to be displaced $\approx 7-9$ inches. This was not the case. As aforementioned, it appears the intrusion by the unknown object and its interaction with the Saturn was at an angle less acute than 90 degrees.

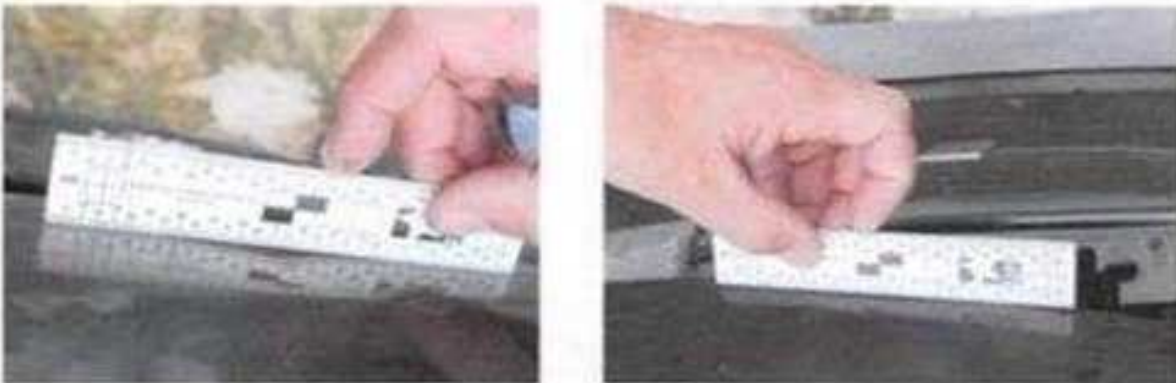
The other two impacts were minute in size and as compared to the damage noted above. These secondary dents did not contain any fractures of the paint and/or contain any foreign material. One was located to the passenger's side while the second one was located in the middle of the hood. The depth of both indents was so miniscule, measurement was difficult if not impossible to measure.

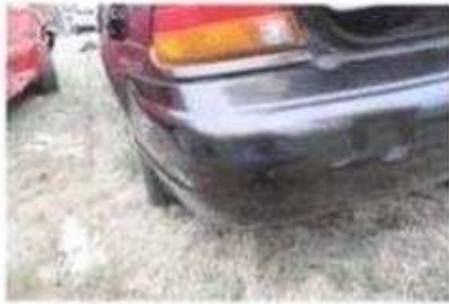
On the rear bumper several superficial marks were observed. These marks were whitish in color with horizontal striations on the driver's side rear corner. It is unknown as to whether these marks are related to this case or were the result of an early incident.

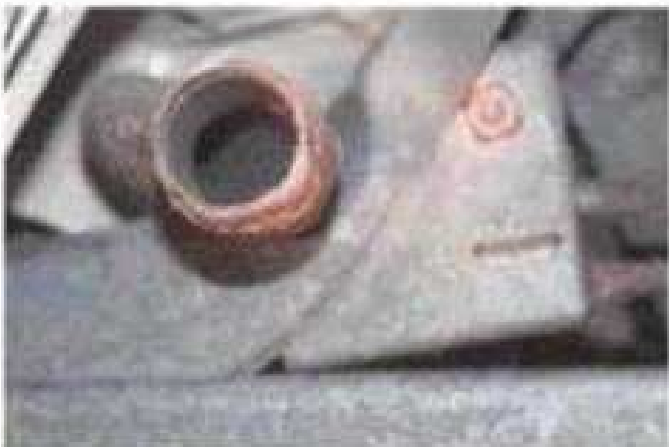
Muffler to tailpipe connection

It was relayed to us that there was mention of a rag or cloth as having been located within the tailpipe of the Saturn's exhaust at the time of the police investigation. During our examination of the vehicle, we found the muffler and tailpipe had been bent backwards or rather now facing towards the front of the vehicle and encased in earthen material. It is more likely than not, this new damage of bending the pipe and muffler was associated with moving the vehicle throughout the back field of the barrack. The tailpipe was extremely corroded and dropped off the muffler with little or no force when we attempted to move it out from under the vehicle. Wet earthen material was packed within the pipe. The earthen material may now contain any leftover evidence of rag and/or cloth which was mentioned as having been placed in the pipe just prior to the collision. It was clear from the condition of the vehicle at the time of the inspection, no care was taken to preserve any type of evidence associated with a rag or cloth within the pipe and/or the condition of the tailpipe itself. Any evidence throughout the entire vehicle was now also compromised due to the condition of the Saturn and nature in which it was secured.

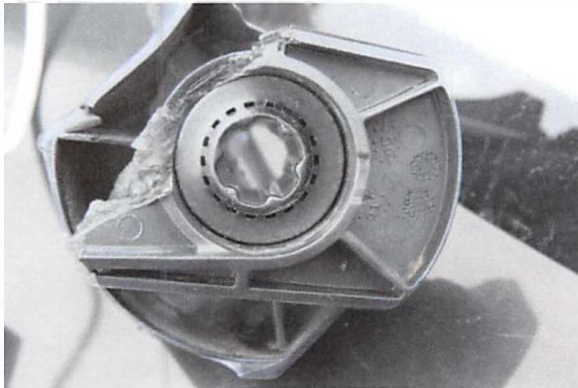
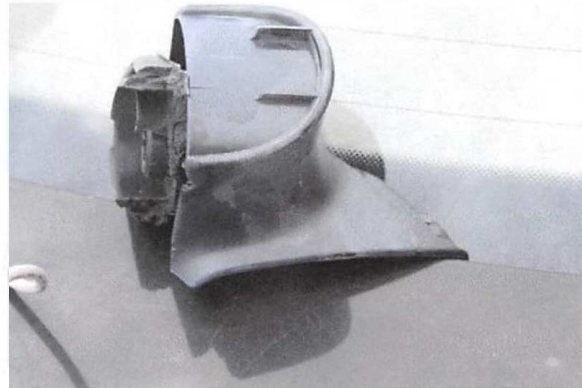
Within the vehicle, two automotive parts were observed. One was a broken part which had a round connecting port with a metal retaining ring. The part also contained a 'Chrysler' logo embossed on a flat portion. We could not locate any type of reference or part number.
