RECONSTITUTED BLACK REPORT

This is an unofficial recreation of [The Black Box Report](#).

Collision Synopsis

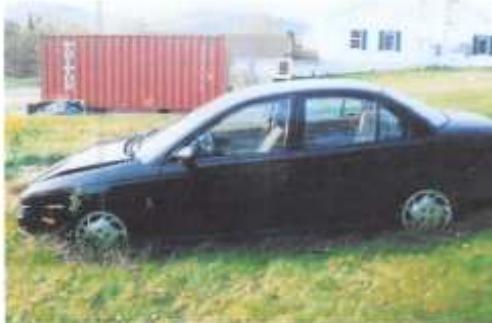
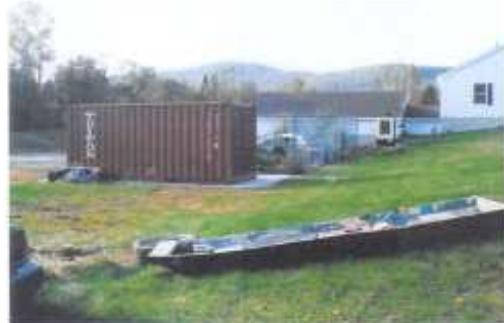
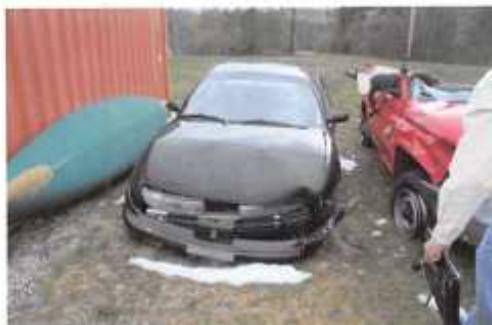
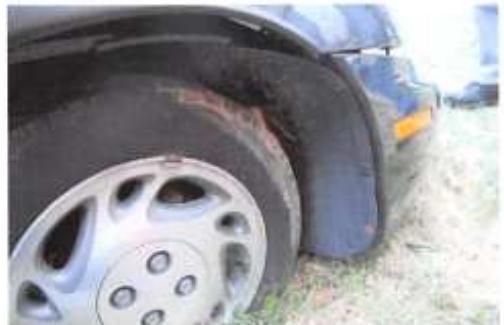
Possibly 2007 photographs based on computer file property

May 1, 2010 during vehicle inspection

On examination of the Saturn in 2010, the general vehicle was in poor condition exclusive of the damage sustained as a result of a collision. It appeared to be in a far better state back in 2007 as shown in photographs.

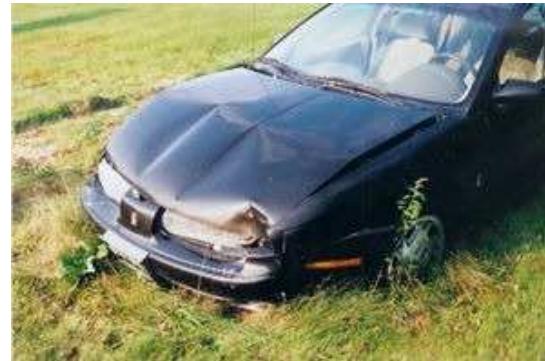
2007 Based on computer file property

As depicted in photographs dating back to \approx 2007, the front bumper is observed still in place as it relates to the damage it had originally obtained. However, during our inspection, the front bumper cover was displaced with the driver's side portion in contact with the ground. The inner 'honeycomb' core was also now exposed. It was apparent that someone or something had disrupted and/or removed the center fasteners of the outer bumper skin; exposing the inner core. It is unknown as to when and or how this action occurred.

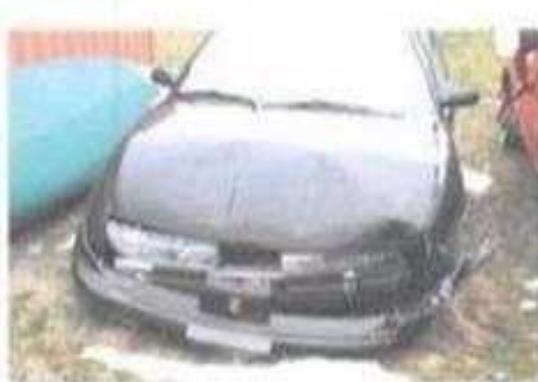
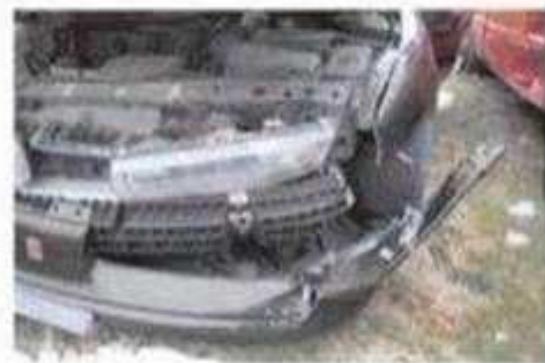
May 1, 2010 During Vehicle Inspection

***Center bumper cover fastners removed
Red arrows depict origin***

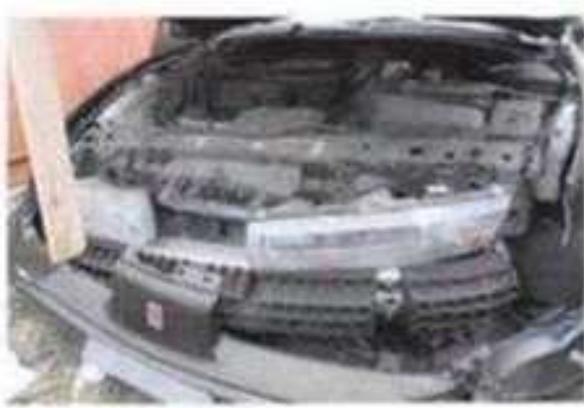
The driver's sub inner core was pushed somewhat inward as compared to the passenger's side. The core also showed lithe damage with a few of the core vents slightly bent. There was also evidence of some abrasion to their outer façade. The mechanism which caused the bending to the core vents cannot be positively be classified as having solely occurred at the locus, as the Saturn has been moved at least once in the field behind the barracks. It is unknown as to whether the moving of the Saturn has caused additional damage to the inner core.

Displaced Driver's Side Core

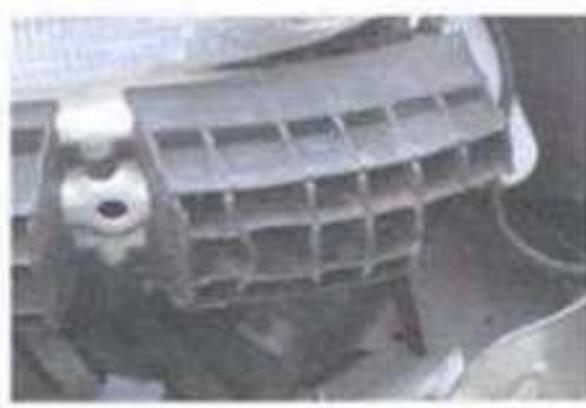
Damaged Core Fins

If the displacement of the core and the damage to the fins was the result of the initial impact in 2004, the intruding object would now need to extend down across the front bumper. However the façade of the intruding object could not have a perfectly vertical façade as it relates to the Saturn's approach. The core is still not pushed back to the extent of the hood damage to justify a perfectly vertical façade, nor does the hood dent have a perfectly vertical appearance, but rather an acute angled indent.

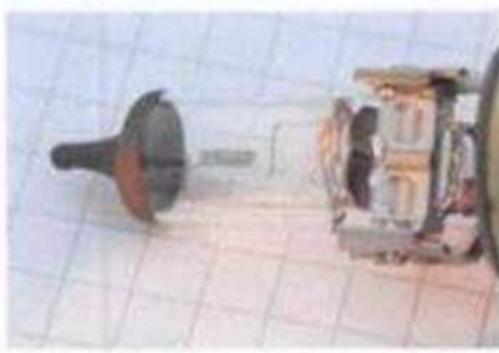
*Low Beam, Driver's Side (off)
Undamaged filament*

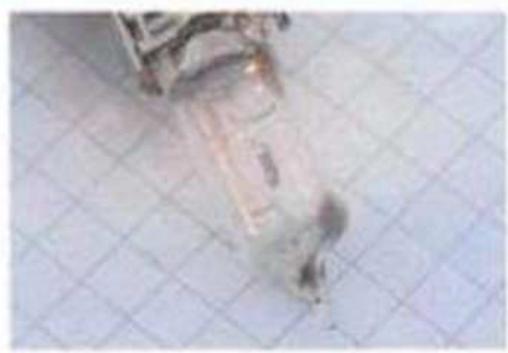
*High Beam, Driver's Side (on) Incandescent
Elongated filament*

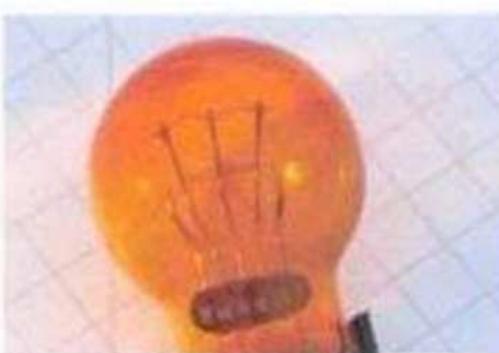
*Driver's Side Amber lamp
Elongated marker filament*

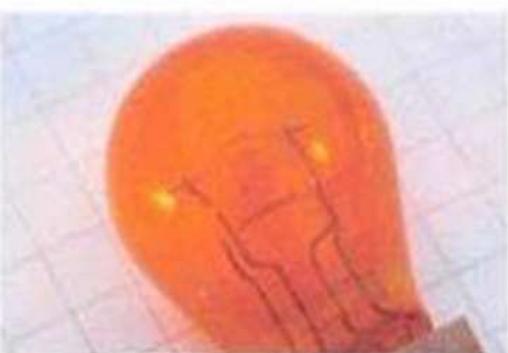
*Passenger's Side Amber Lamp
Elongated marker filament*

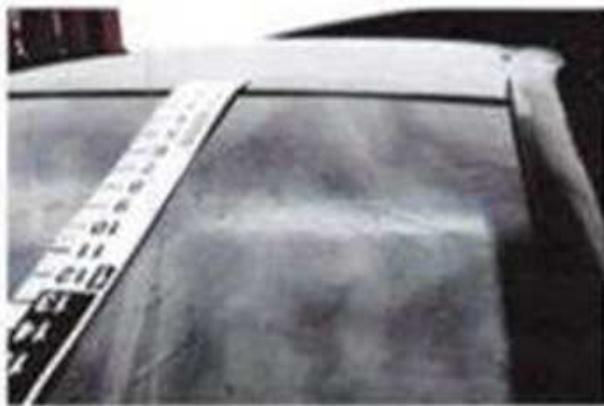
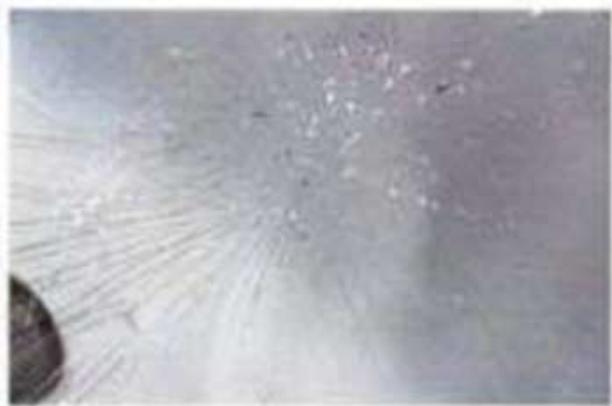
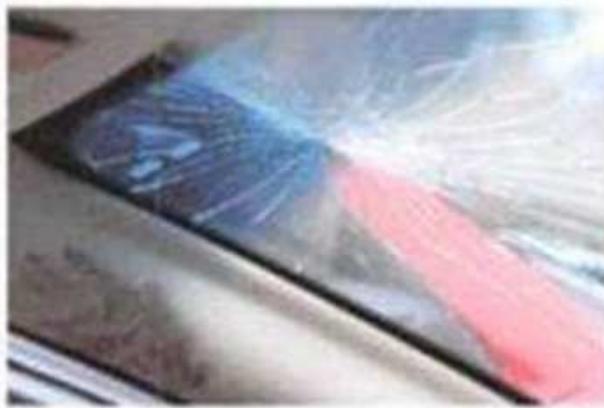
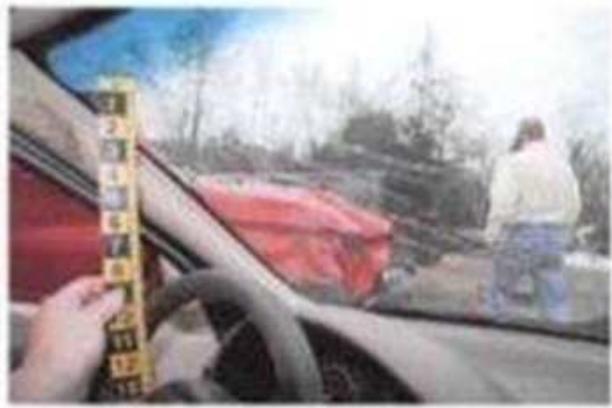
A small circular (stellar) pattern impact to the windshield was located \approx 8 inches above the crest of the steering wheel. The interior portion of the pattern did not have any course feeling when touched by the palm of a hand. The exterior portion of the windshield did have cutting edges along each fracture. There was also a small indentation to the stellar pattern on the inside; rendering the fracture as having occurred from the interior by an unknown object. The placement of the stellar impact is slightly lateral of the driver's seated position and towards the driver's side 'A' pillar post. The stellar impact is also vertically located \approx 5 to 6 inches down from the top section of the windshield and within the tinted area as assigned by the ASI level.

There are at least four if not more possibilities as to how this fracture occurred. First, during airbag deployment when the bag inflates and makes contact with the windshield, however, the airbag fabric had been removed and any attempt to rule out this possibility has been compromised. Further discussion regarding the airbag status will be forthcoming.

Secondly by means of the operator striking their head on the windshield during an impact. There was no evidence of any hair fibers and/or root within the break. The fracture to the glass was clean with no foreign material and appeared too small as compared to a typical head strike.

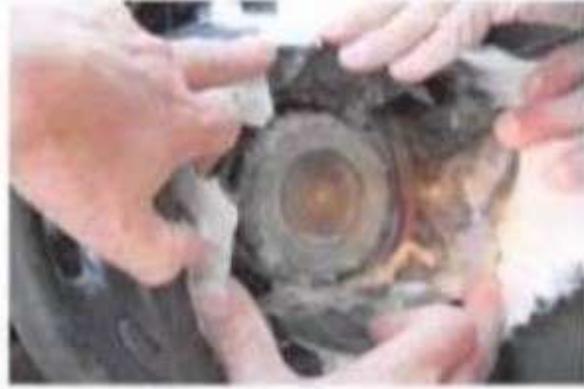
Driver's Side airbag actuator

The fabric airbags themselves were cut at the base and removed from the vehicle as shown in the photographs above by unknown persons. This may have been for the reason of examination by laboratory personnel. In doing so, evidence of any contact with one or both airbags by either the operator and/or any person seated in the passenger's seat can be analyzed by authorities. These airbags did deploy within a period of time relative to the situation at hand.

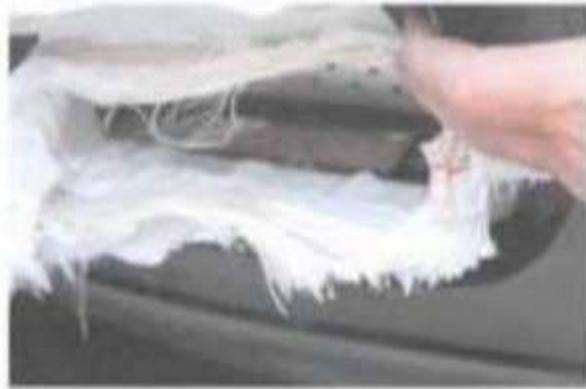
Passenger 's Side airbag actuator

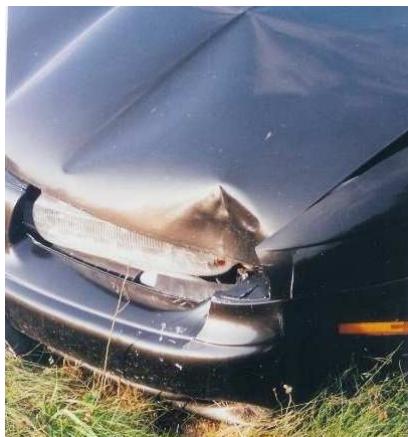
Photograph from 2007

There were ≈ three areas of contact to the front of the Saturn. The first one which contained more significant damage than the other two was a frontal impact to the driver's front corner. It should be noted; at the time of our investigation, the Saturn had been moved throughout the back field of the barracks. The front bumper was now hanging off the vehicle and not in the same condition as depicted in photographs taken in the year 2007, it is unknown what type of damage was associated with the vehicle back in 2004. However, the actually structural damage to the hood was consistent and unchanged.

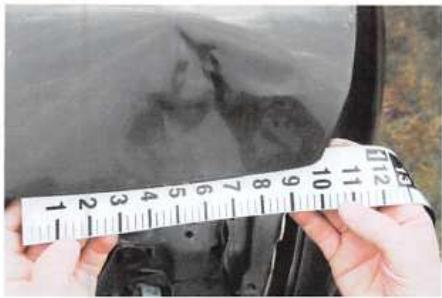
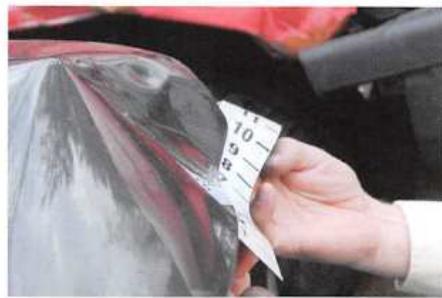
On close examination of the hood damage, the width was \approx 7 inches with a maximum depth of \approx 9 inches. The overall height was \approx 4 inches and angled at \approx 45 degrees off perpendicular. There was no fracture of the paint or foreign material embedded. The overall damage was not smooth but rather uneven and did not contain the classic geometrical shape of a tree's outer façade.

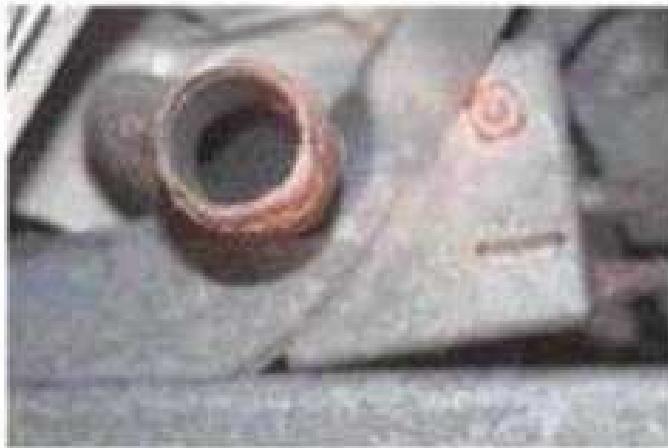
Muffler to tailpipe connection

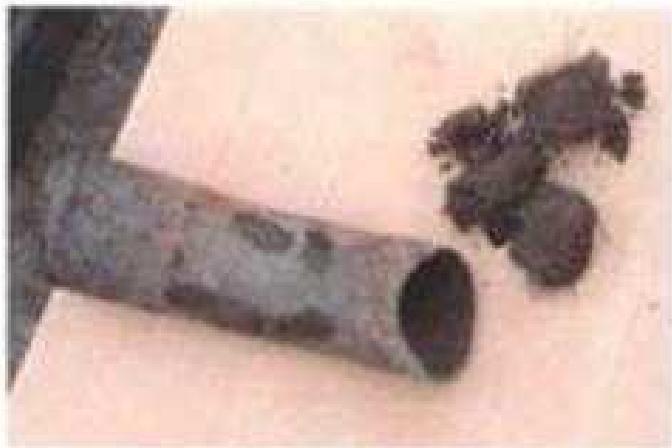
Tailpipe with earthen material
