Collision Synopsis

For Parkka Collision Consultants, Inc.

Daniel James Parkka
Actar 760 / Collision Reconstructionist

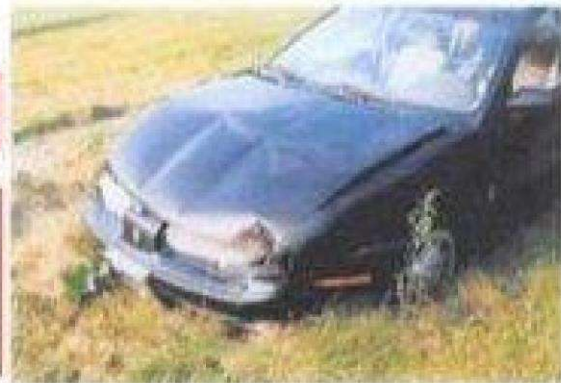
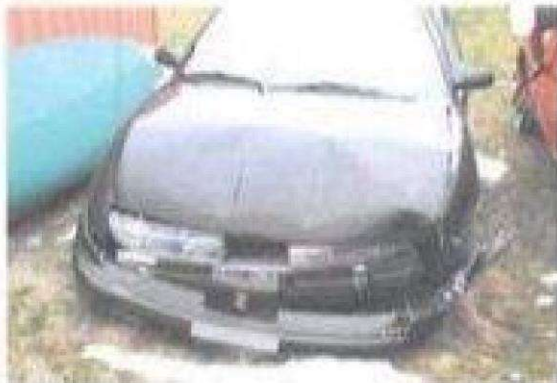
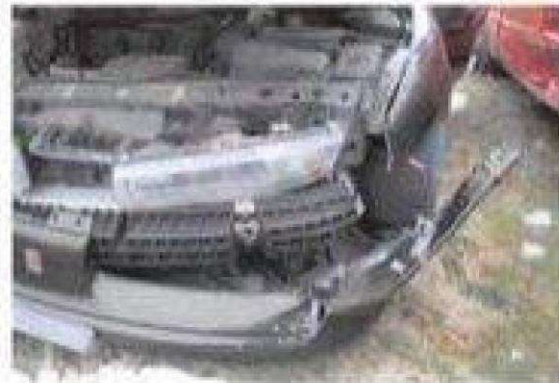
As depicted in photographs dating back to = 2007, the front bumper is observed still in place as it relates to the damage it had originally obtained. However, during our inspection, the front bumper cover was displaced with the driver's side portion in contact with the ground. The inner 'honeycomb' core was also now exposed. It was apparent that someone or something had disrupted and/or removed the center fasteners of the outer bumper skin; exposing the inner core. It is unknown as to when and or how this action occurred.

May 1, 2010 During Vehicle Inspection

*Center bumper cover fasteners removed
Red arrows depict origin*

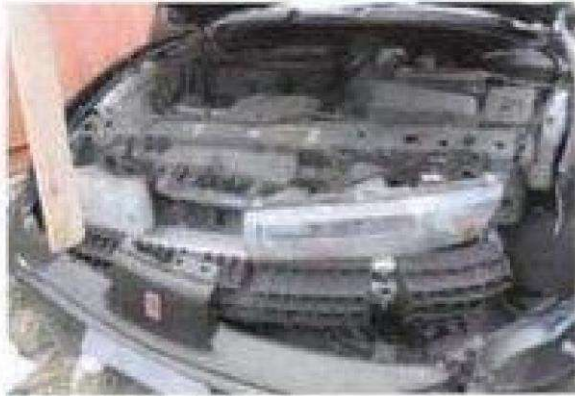
The driver's side inner core was pushed somewhat inward as compared to the passenger's side. The core also showed little damage with a few of the core vents slightly bent. There was also evidence of some abrasion to their outer façade. The mechanism which caused the bending to the core vents cannot be positively be classified as having solely occurred at the locus, as the Saturn has been moved at least once in the field behind the barracks. It is unknown as to whether the moving of the Saturn has caused additional damage to the inner core.

Displaced Driver's Side Core

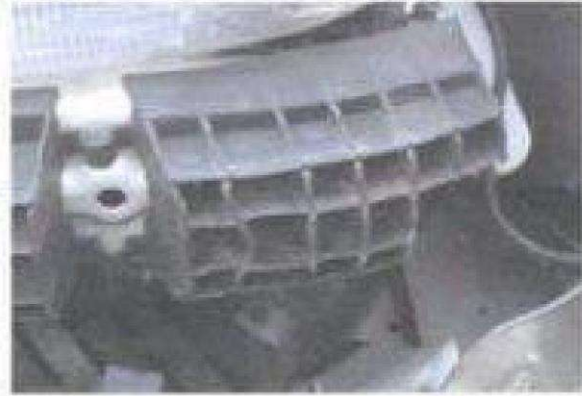
Damaged Core Fins

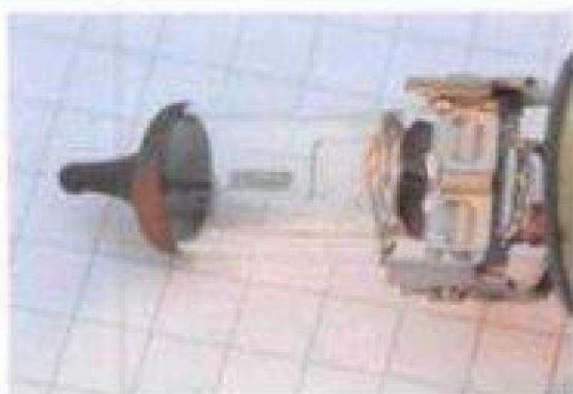
If any of the exterior lamp filaments were incandescent (illuminating) at the time of the collision, the filament(s) would have elongated and uncoiled as a result of being ductile. Inertia of the filament(s) during a collision causes this to occur resulting in what is described as 'hot shock'. As depicted in the photographs which illustrate the damage to the Saturn, the majority of the dynamic collapse is in the area of the corner marker light and headlight assembly. An examination of the headlight bulbs revealed the high beams were on at the time of this impact. The filament showed classic evident of elongation while the low beam maintained its original coil. This is of important as it relates to the illuminated visual field ahead of the operator at the time of any or all impacts.

*Low Beam, Driver's Side (off)
Undamaged filament*

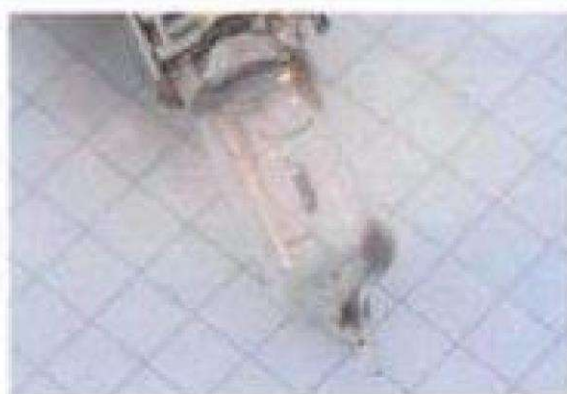
*High Beam, Driver's Side (on) Incandescent
Elongated filament*

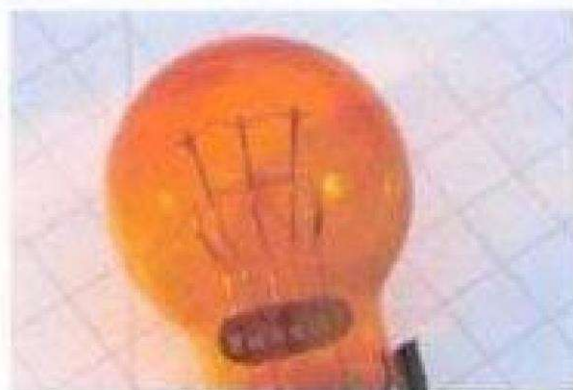
The front amber corner bulbs contained both marker and turn signal filaments and were not of the same make. The marker filament showed signs of elongation under low magnification. This elongation is consistent with the filament being incandescent at the time of the collision. Both turn signal filament maintained their original coiled appearance; rendering their status as being inconclusive.

*Driver's Side Amber lamp
Elongated marker filament*

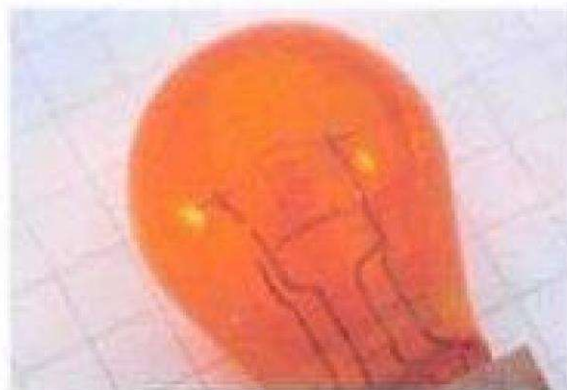
*Passenger's Side Amber Lamp
Elongated marker filament*

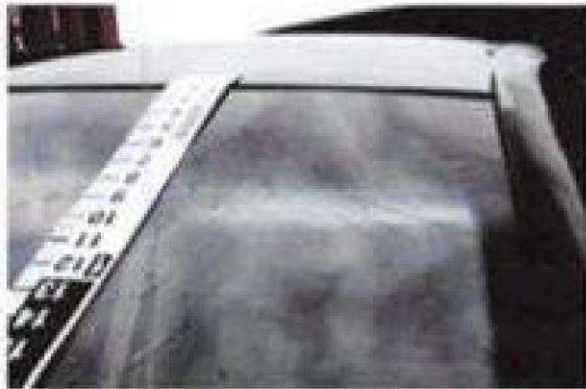
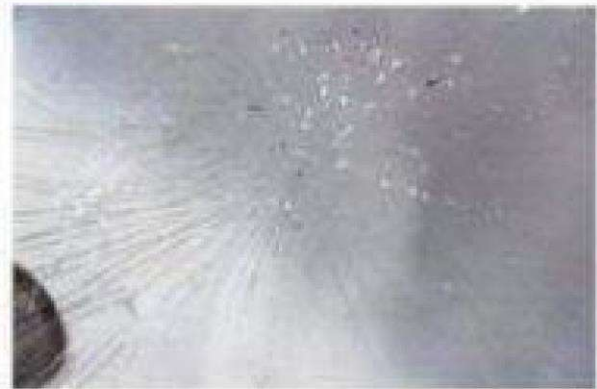
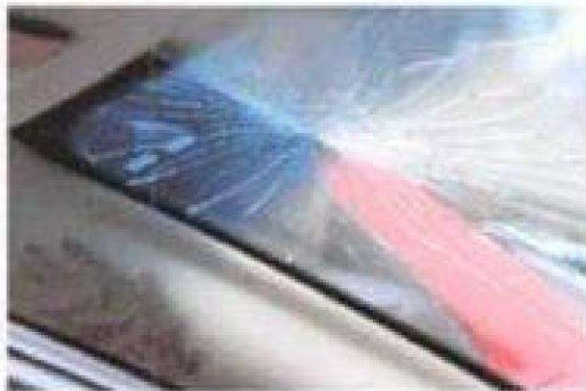
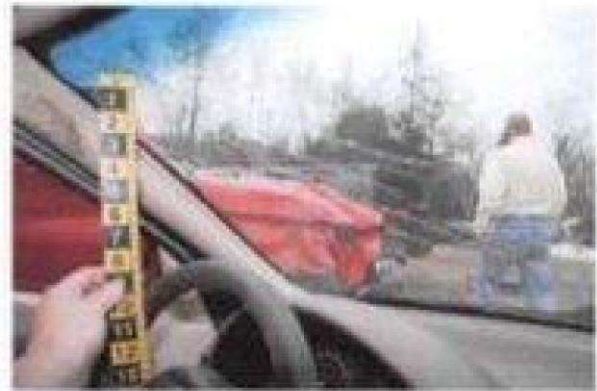
A small circular (stellar) pattern impact to the windshield was located \approx 8 inches above the crest of the steering wheel. The interior portion of the pattern did not have any coarse feeling when touched by the palm of a hand. The exterior portion of the windshield did have cutting edges along each fracture.

There was also a small indentation to the stellar pattern on the inside; rendering the fracture as having occurred from the interior by an unknown object. The placement of the stellar impact is slightly lateral of the driver's seated position and towards the driver's side "A" pillar post. The stellar impact is also vertically located \approx 5 to 6 inches down from the top section of the windshield and within the tinted area as assigned by the ASI level.

There are at least four if not more possibilities as to how this fracture occurred. First, during airbag deployment when the bag inflates and makes contact with the windshield, however, the airbag fabric had been removed and any attempt to rule out this possibility has been compromised. Further discussion regarding the airbag status will be forthcoming.

Secondly by means of the operator striking their head on the windshield during an impact. There was no evidence of any hair fibers and/or root within the break. The fracture to the glass was clean with no foreign material and appeared too small as compared to a typical head strike.

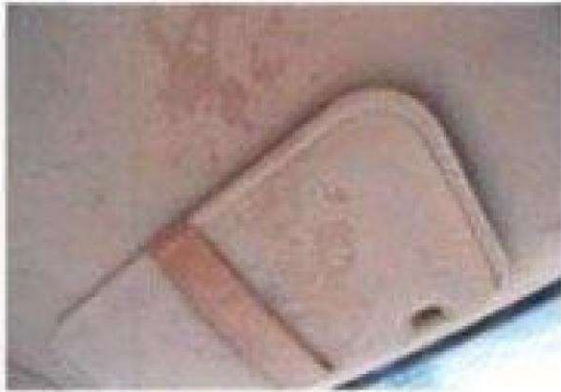
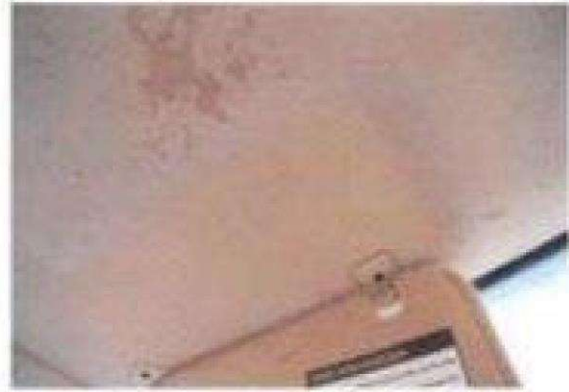
With this said, the interior roof line was stained with a reddish appearance which was in an area forward and above the driver's position. According to the police report, they classified this as a red liquid and reference a box of Franzia Wine within the vehicle. The box of wine would have appeared similar to the exemplar one shown to the right. As aforementioned, the visor was believed to have been in a position folded against the roof. As shown in the photographs below, the area behind the visor when in a lowered position is clean of any liquid aspersion.

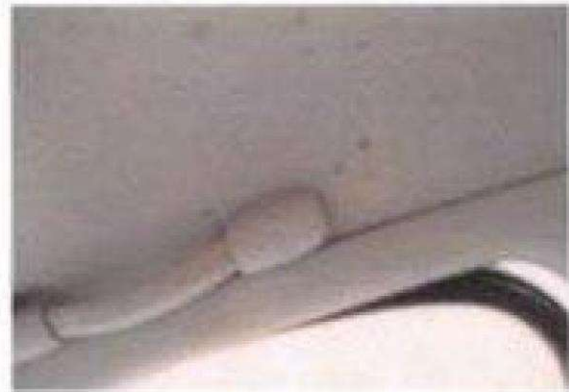
The aspersion then appears to have been projected or sprayed across the roof line towards the passenger's side. The spattered did not have the classic signs of an elongated nature to the naked eye as associated with blood and did not contain the classic tail. However, this does not rule out the possibility that the aspersion was not of a biological nature without a proper analysis.

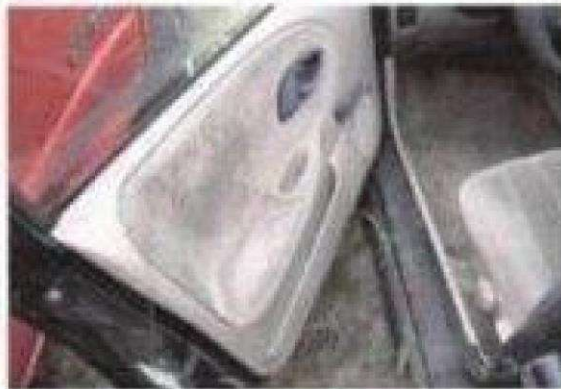
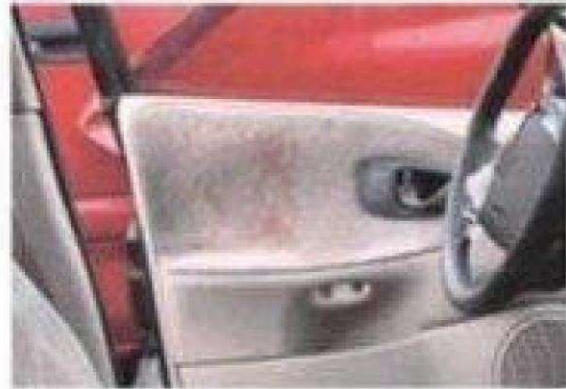
Another area containing the same type of stain was located on the driver's door panel. This area was heavily saturated and had a downward type spray. What was interesting about this area was it mainly was positioned on the aft section of the door panel with almost a vertical boarder going down the right side just aft of the interior handle. There was also no liquid aspersion on the driver's seat.

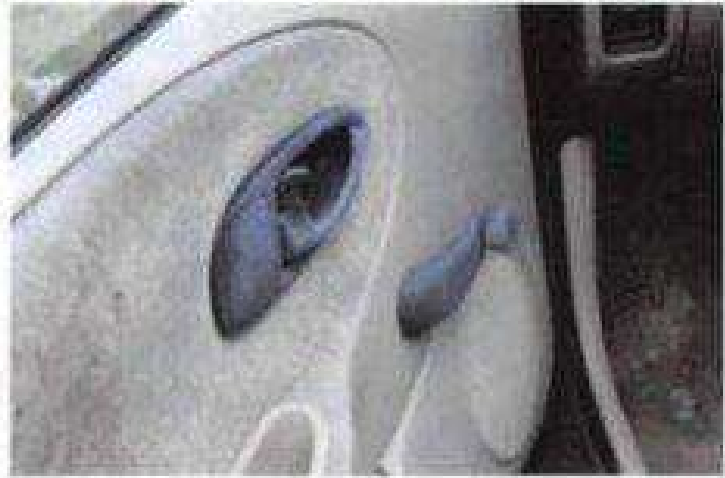
As it relates to the driver's door panel, a blackish print pattern was located on the arm rest. The print was all of the door handle cup and wrapped slightly along the right edge. It is unknown at this point what if anything had developed this mark. Both the interior door handle and window crank had a whitish appearance; similar to the chemicals used to dust the vehicle for forensic prints. The foreign chemical could also have been deposited by the airbag during deployment. Given the extended period of time this vehicle has been sitting in the environment, it could not be positively identified.

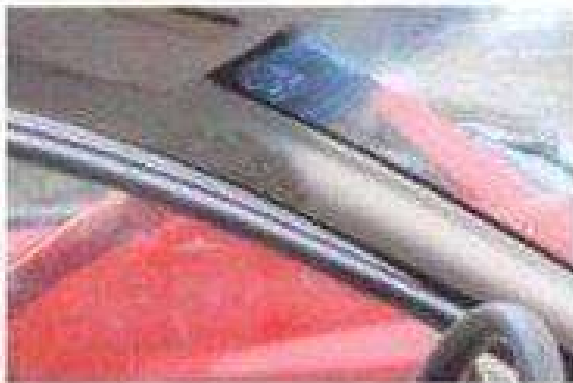
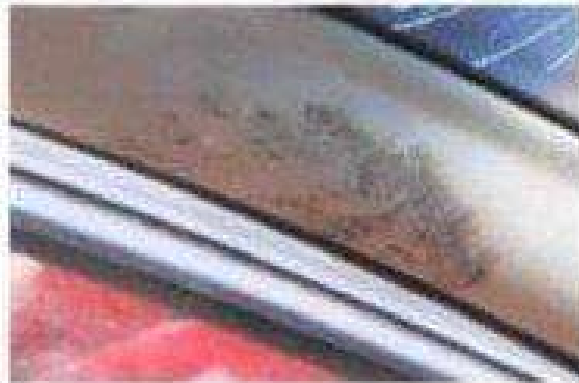
On the 'A' pillar post and adjacent to the stellar break to the windshield, a brown or blackish type smear is evident which almost has the same visual color as the print on the driver's door interior arm rest. To the naked eye, it gives the basic impression of possibly a left hand print versus a right with three extended digits pointing towards the roofline. However, again, a specialized technical examination of this mark would need to be conducted by other persons.

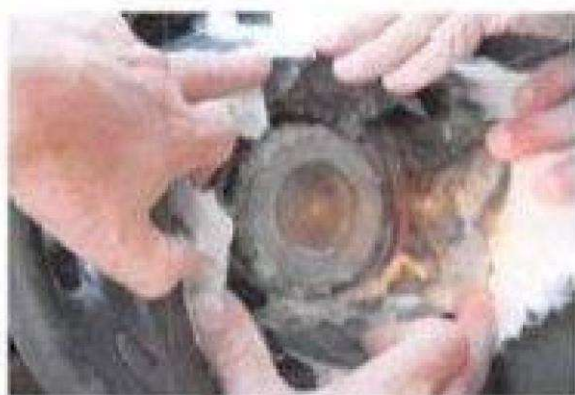
Driver's Side airbag actuator

The fabric airbags themselves were cut at the base and removed from the vehicle as shown in the photographs above by unknown persons. This may have been for the reason of examination by laboratory personnel. In doing so, evidence of any contact with one or both airbags by either the operator and/or any person seated in the passenger's seat can be analyzed by authorities. These airbags did deploy within a period of time relative to the situation at hand.

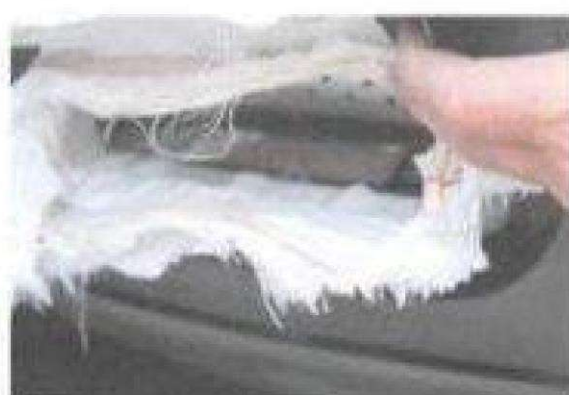
Passenger's Side airbag actuator

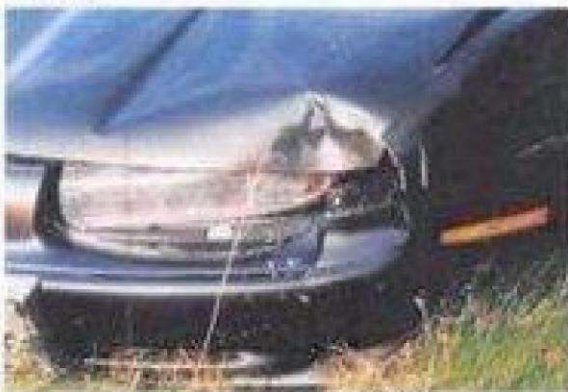
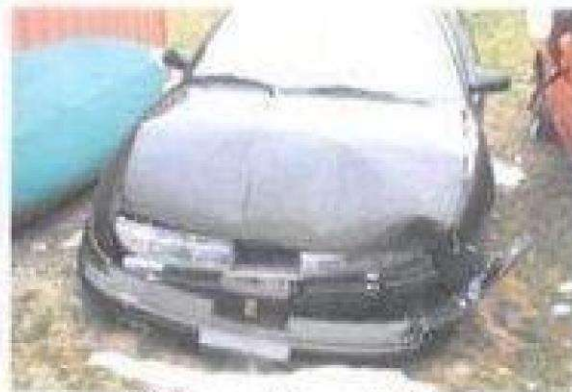
There were ≈ three areas of contact to the front of the Saturn. The first one which contained more significant damage than the other two was a frontal impact to the driver's front corner. It should be noted; at the time of our investigation, the Saturn had been moved throughout the back field of the barracks. The front bumper was now hanging off the vehicle and not in the same condition as depicted in photographs taken in the year 2007. It is unknown what type of damage was associated with the vehicle back in 2004. However, the actually structural damage to the hood was consistent and unchanged.

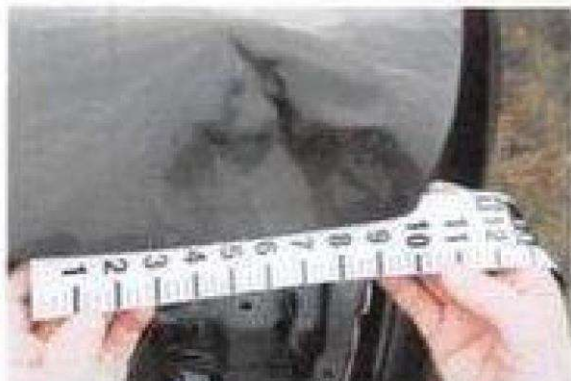
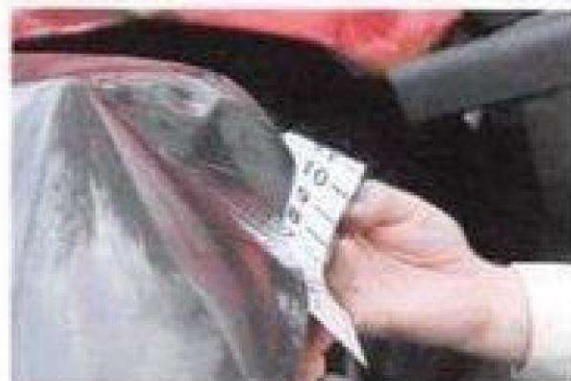
On close examination of the hood damage, the width was ≈ 7 inches with a maximum depth of ≈ 9 inches. The overall height was ≈ 4 inches and angled at ≈ 45 degrees off perpendicular. There was no fracture of the paint or foreign material embedded. The overall damage was not smooth but rather uneven and did not contain the classic geometrical shape of a tree's outer façade.

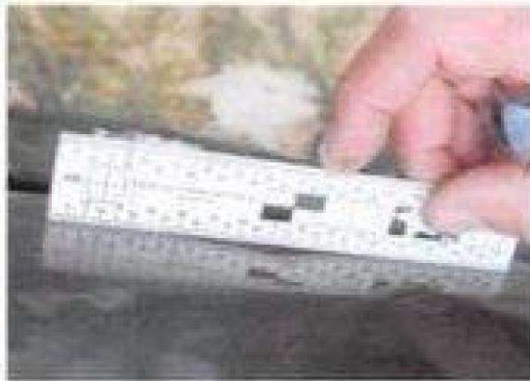
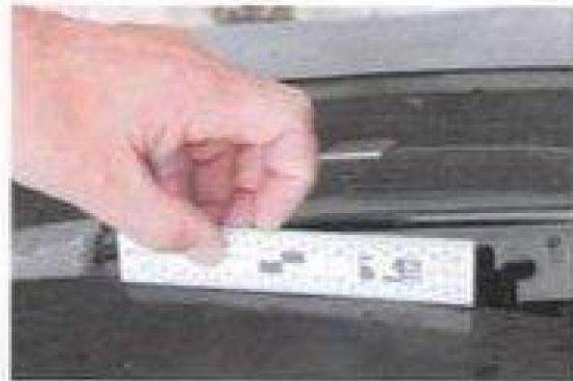
The other two impacts were minute in size and as compared to the damage noted above. These secondary dents did not contain any fractures of the paint and/or contain any foreign material. One was located to the passenger's side while the second one was located in the middle of the hood. The depth of both indents was so miniscule, measurement was difficult if not impossible to measure.

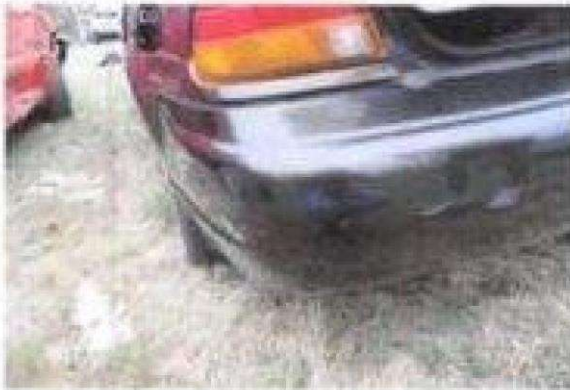
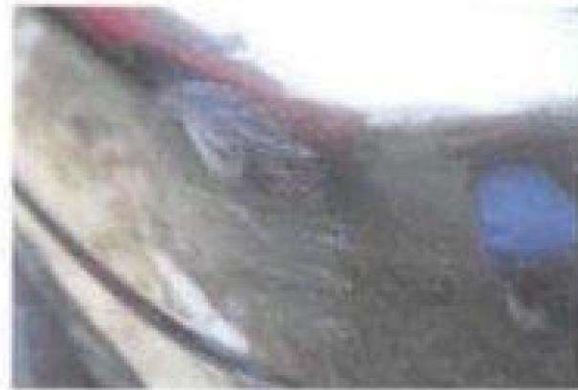
On the rear bumper several superficial marks were observed. These marks were whitish in color with horizontal striations on the driver's side rear corner. It is unknown as to whether these marks are related to this case or were the result of an early incident.

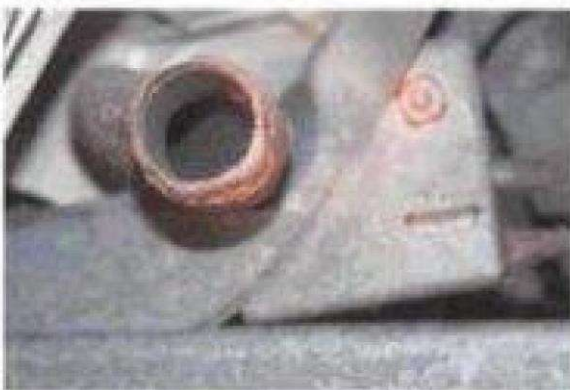
Muffler to tailpipe connection

It was relayed to us that there was mention of a rag or cloth as having been located within the tailpipe of the Saturn's exhaust at the time of the police investigation. During our examination of the vehicle, we found the muffler and tailpipe had been bent backwards or rather now facing towards the front of the vehicle and encased in earthen material. It is more likely than not, this new damage of bending the pipe and muffler was associated with moving the vehicle throughout the back field of the barracks. The tailpipe was extremely corroded and dropped off the muffler with little or no force when we attempted to move it out from under the vehicle. Wet earthen material was packed within the pipe. The earthen material may now contain any leftover evidence of rag and/or cloth which was mentioned as having been placed in the pipe just prior to the collision. It was clear from the condition of the vehicle at the time of the inspection, no care was taken to preserve any type of evidence associated with a rag or cloth within the pipe and/or the condition of the tailpipe itself. Any evidence throughout the entire vehicle was now also compromised due to the condition of the Saturn and nature in which it was secured.

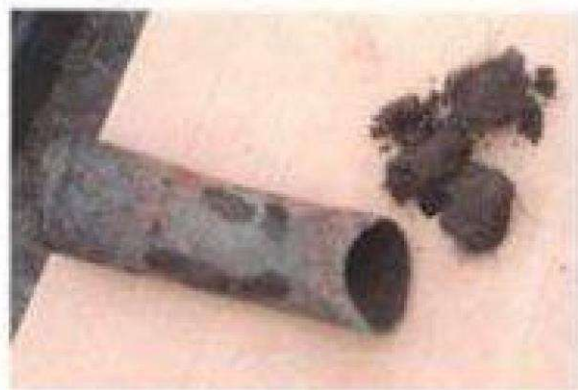
Tailpipe with earthen material
