RECONSTITUTED BLACK REPORT

Collision Synopsis

Vehicle Examination

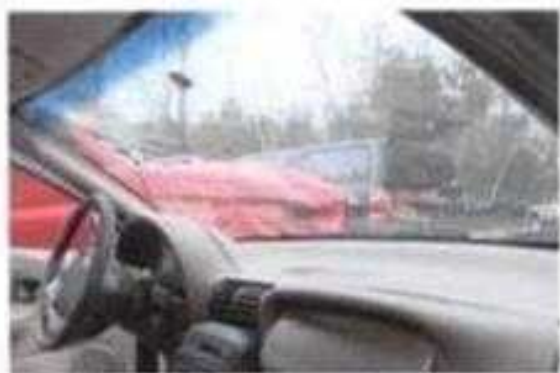
On examination of the Saturn in 2010, the general vehicle was in poor condition exclusive of the damage sustained as a result of a collision. It appeared to be in a far better state back in 2007 as shows in photographs.

The deterioration would more likely than not be a result of weather over the years and/or moving the vehicle throughout the back field of the NHSP barracks, The Saturn was not in a secured, sheltered environment. The vehicle had passed a yearly safety inspection evident by an inspection sticker affixed to the front windshield, expiring in October 2004 and had

accumulated 152,046 miles as per its odometer. There was no indication of any fixed foreign material or objects within the vehicle that would interfere with the operation and/or the forward or lateral visual observations from the operator.

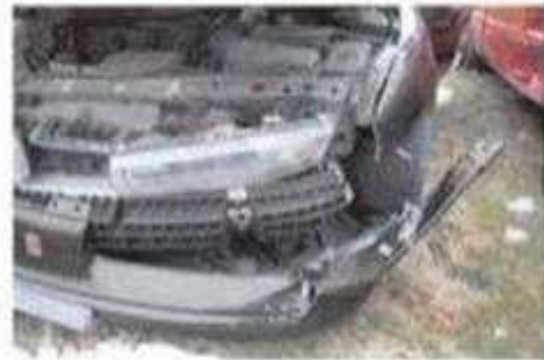
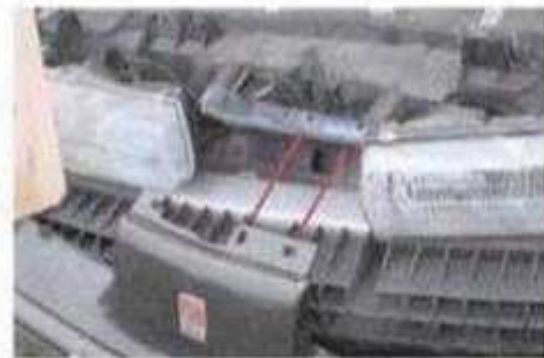
The driver's sub inner core was pushed somewhat inward as compared to the passenger's side. The core also showed lithe damage with a few of the core vents slightly bent. There was also evidence of some abrasion to their outer façade. The mechanism which caused the bending to the core vents cannot be positively be classified as having solely occurred at the locus, as the Saturn has been moved at least once in the field behind the barracks. It is unknown as to whether the moving of the Saturn has caused additional damage to the inner core.

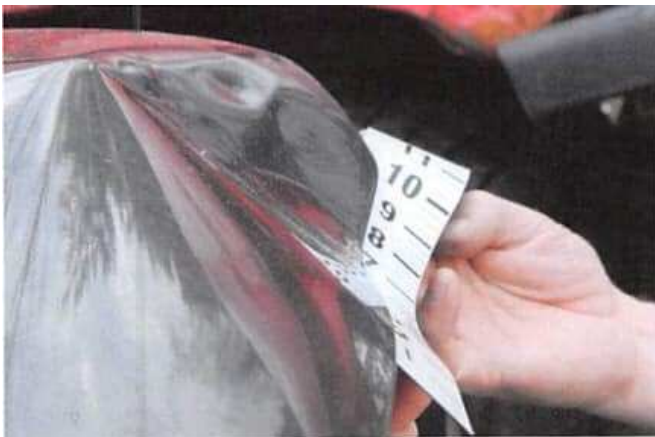
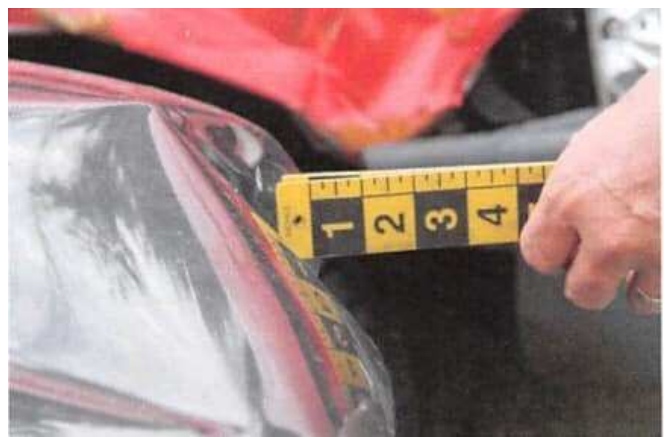
If the displacement of the core and the damage to the fins was the result of the initial impact in 2004, the intruding object would now need to extend down across the front bumper. However the façade of the intruding object could not have a perfectly vertical façade as it relates to the Saturn's approach. The core is still not pushed back to the extent of the hood damage to justify a perfectly vertical façade, nor does the hood dent have a perfectly vertical appearance, but rather an acute angled indent.

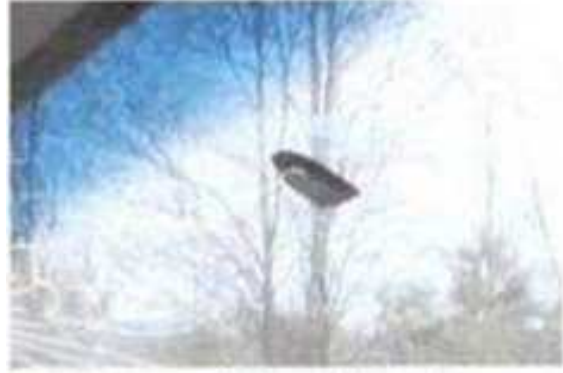
The interior mirror was missing with the supporting bracket still in place and did not show any sign of damage. In order to take the mirror off the windshield, it needs to be elevated towards the roofline and off the support. To attach the mirror, it needs to be slipped down onto the support and within a grooved channel. The mirror is then secured to the bracket by tightening an allen screw or nut fastener. If the allen screw were loose, the mirror could possibly be dislodged during contact with the operator as they are propelled towards the windshield during a frontal impact. This does not rule out the possibility that the mirror had been removed by police personnel for analysis and/or was initially missing prior to the incident.

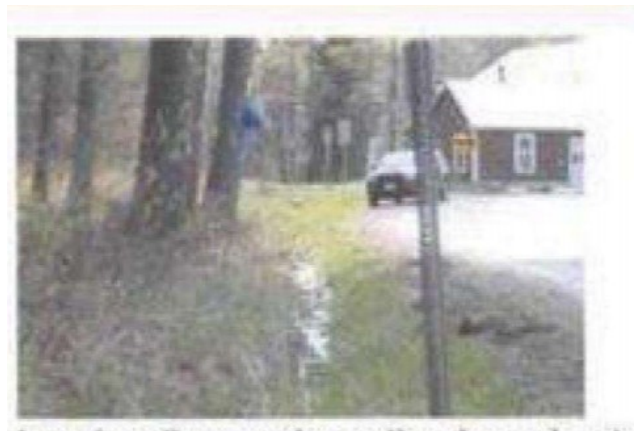
As it relates to what could have caused those two events to occur nearly simultaneously with a 'Non-deployment' occurring first; the edge of the roadway where Maura's Saturn was located contains a small ravine adjacent to a tree line. If the Saturn entered this ravine, it may have resulted in a 'waking up' of the SDM unit and recording a 'Non-deployment' event. The vehicle would then need to move \approx 1 foot to the tree line to result in the 'Deployment' event be commanded with airbag after having struck the tree line. If the front wheel assembly went into the ravine and/or struck the far side wall of the ravine adjacent to the treeline, the overhanging front end of the Saturn would now be closer to the base of either a tree or fixed object to result in a deployment command.

However, the damage is not consistent with striking a tree which has a perfectly vertical façade from the ground up. The damage is more consistent with a less acute angle of interaction between the two. If the front of the Saturn were down in the ravine, this would now change the horizontal pitch of the vehicle from a horizontal plain consistent with the pavement and place the front end of the vehicle more at an angle to the vertical façade of a tree. Or, if the angle of the tree were more of an acute angle as

shown in the photograph above with the blue ribbon, the angle to which these two engage could now be explained. This would allow the finite damage to the core fins to occur. However, the physical damage to the vehicle's hood and its configuration still are at question.

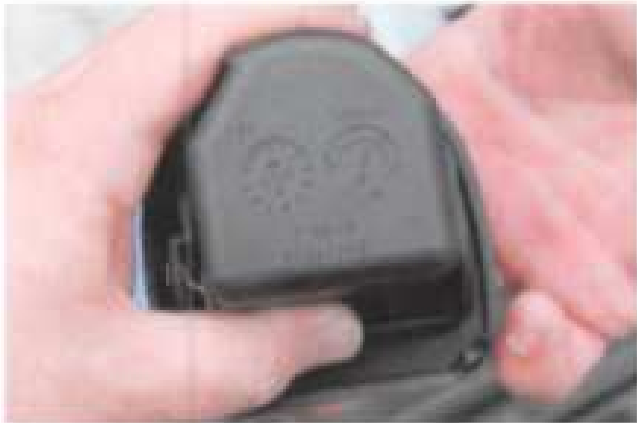
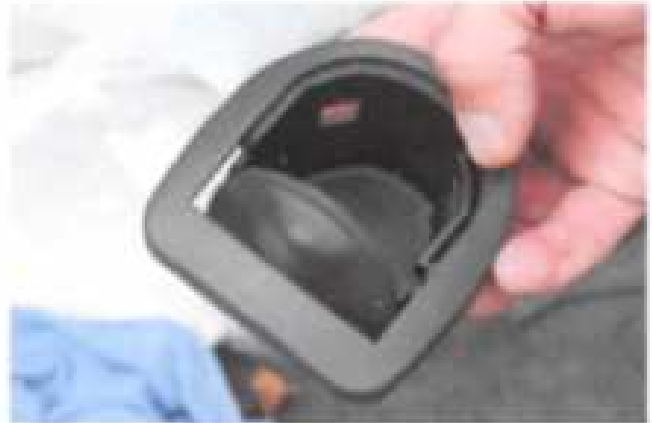
The second part was undamaged and appeared to be a type of coin holder with lid. Part number 21041748 was embossed on the back with other date. There was no automotive manufacturing symbol.

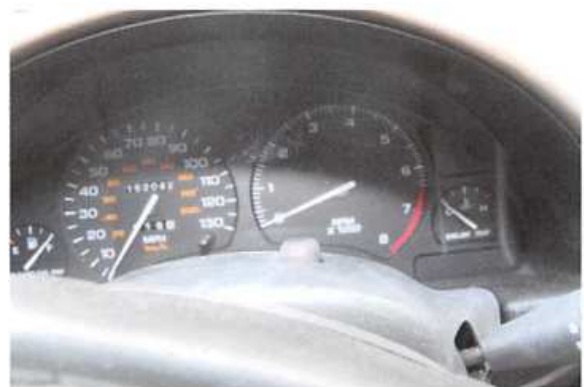
On an examination of the engine compartment, we found the oil level, transmission and brake reservoir contained adequate lubrication. The trunk of the vehicle had several full quarts of SAE 10 W20 motor oil in a case which originally contained approximately 12 bottles. A bottle of windshield fluid was also evident. The battery was dead but still connected and the fuel gauge indicated a full tank.
