RECONSTITUTED BLACK REPORT

This is an unofficial recreation of [The Black Box Report](#).

Collision Synopsis

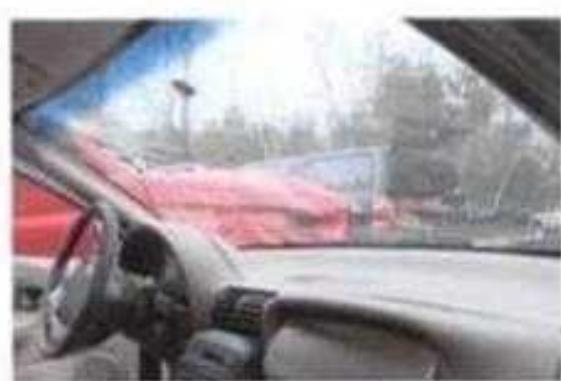
The deterioration would more likely than not be a result of weather over the years and/or moving the vehicle throughout the back field of the NHSP barracks. The Saturn was not in a secured, sheltered environment. The vehicle had passed a yearly safety inspection evident by an inspection sticker affixed to the front windshield, expiring in October 2004 and had

accumulated 152,046 miles as per its odometer. There was no indication of any fixed foreign material or objects within the vehicle that would interfere with the operation and/or the forward or lateral visual observations from the operator.

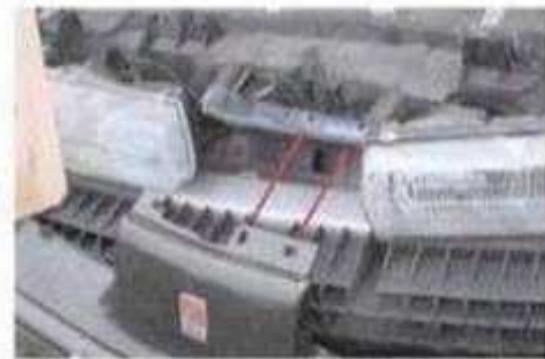
The driver's sub inner core was pushed somewhat inward as compared to the passenger's side. The core also showed lithe damage with a few of the core vents slightly bent. There was also evidence of some abrasion to their outer façade. The mechanism which caused the bending to the core vents cannot be positively be classified as having solely occurred at the locus, as the Saturn has been moved at least once in the field behind the barracks. It is unknown as to whether the moving of the Saturn has caused additional damage to the inner core.

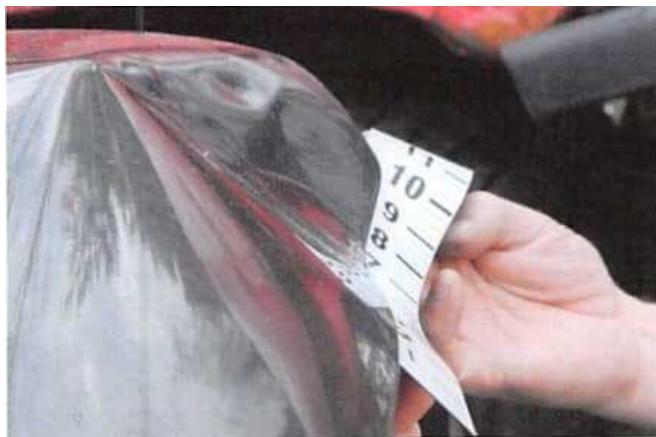
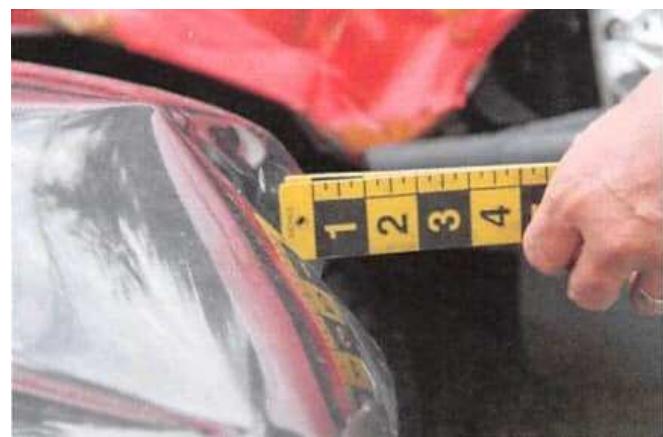
If the displacement of the core and the damage to the fins was the result of the initial impact in 2004, the intruding object would now need to extend down across the front bumper. However the façade of the intruding object could not have a perfectly vertical façade as it relates to the Saturn's approach. The core is still not pushed back to the extent of the hood damage to justify a perfectly vertical façade, nor does the hood dent have a perfectly vertical appearance, but rather an acute angled indent.

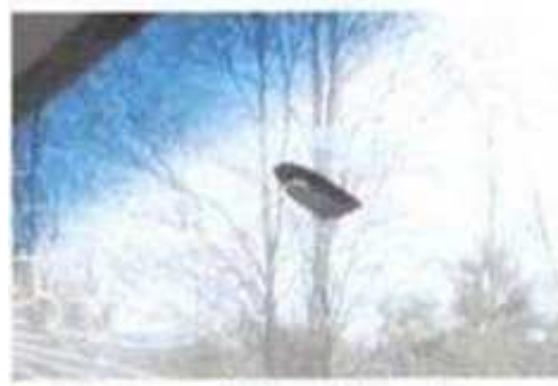
The interior mirror was missing with the supporting bracket still in place and did not show any sign of damage. In order to take the mirror off the windshield, it needs to be elevated towards the roofline and off the support. To attach the mirror, it needs to be slipped down onto the support and within a grooved channel. The mirror is then secured to the bracket by tightening an allen screw or nut fastener. If the allen screw were loose, the mirror could possibly be dislodged during contact with the operator as they are propelled towards the windshield during a frontal impact. This does not rule out the possibility that the mirror had been removed by police personnel for analysis and/or was initially missing prior to the incident.

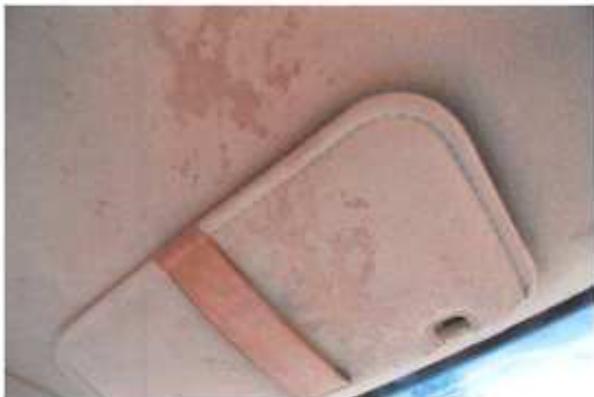
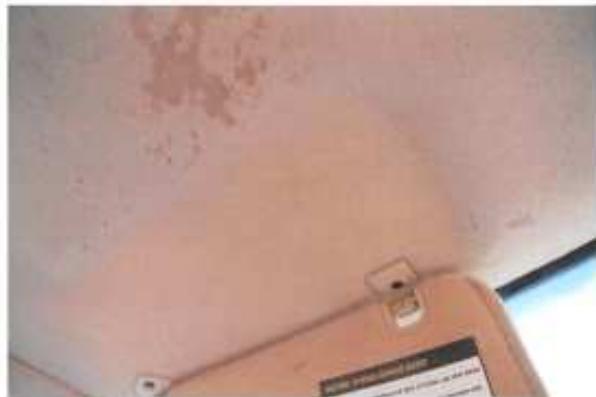
With this said, the interior roof line was stained with a reddish appearance which was in an area forward and above the driver's position. According to the police report, they classified this as a red liquid and reference a box of Franzia Wine within the vehicle. The box of wine would have appeared similar to the exemplar one shown to the right. As aforementioned, the visor was believed to have been in a position folded against the roof. As shown in the photographs below, the area behind the visor when in a lowered position is clean of any liquid aspersion.

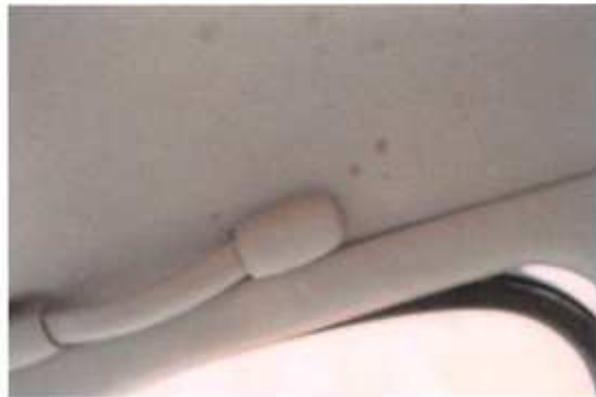
The aspersion then appears to have been projected or sprayed across the roof line towards the passenger's side. The spattered did not have the classic signs of an elongated nature to the naked eye as associated with blood and did not contain the classic tail. However, this does not rule out the possibility that the aspersion was not of a biological nature without a proper analysis.

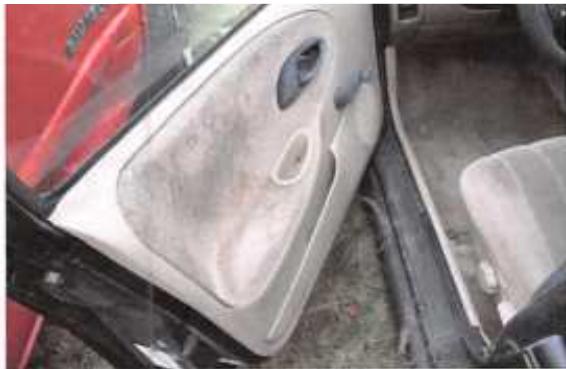
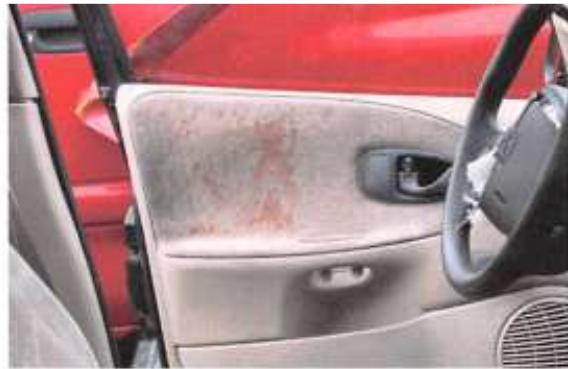
Another area containing the same type of stain was located on the driver's door panel. This area was heavily saturated and had a downward type spray. What was interesting about this area was it mainly was positioned on the aft section of the door panel with almost a vertical boarder going down the right side just aft of the interior handle. There was also no liquid aspersion on the driver's seat.

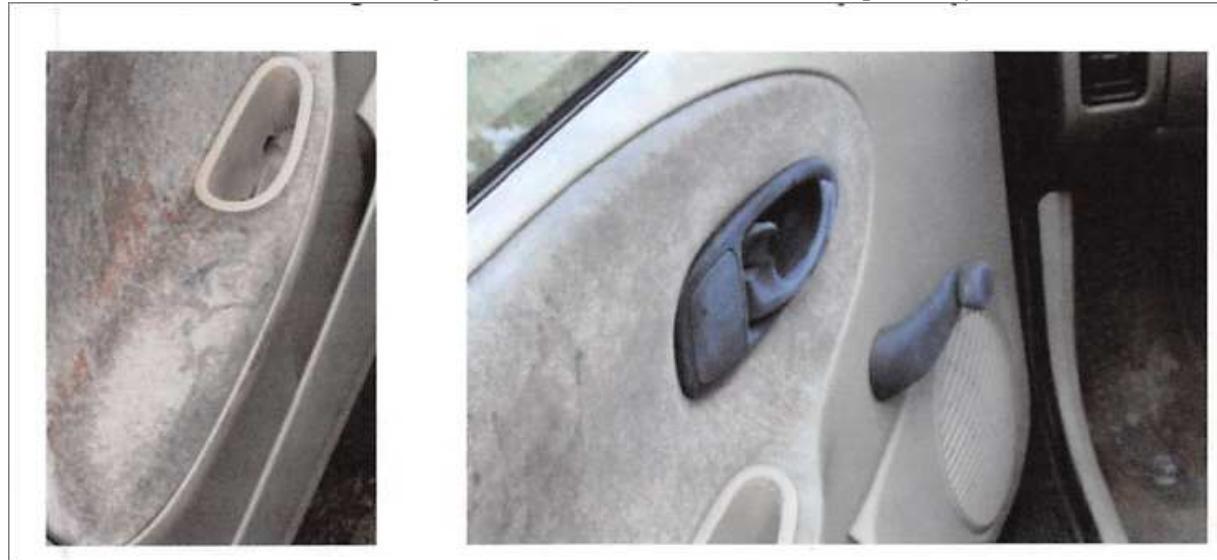
As it relates to the driver's door panel, a blackish print pattern was located on the arm rest. The print was aft of the door handle cup and wrapped slightly along the right edge. It is unknown at this point what if anything had developed this mark. Both the interior door handle and window crank had a whitish appearance; similar to the chemicals used to dust the vehicle for forensic prints. The foreign chemical could also have been deposited by the airbag during deployment. Given the extended period of time this vehicle has been sitting in the environment, it could not be positively identified.

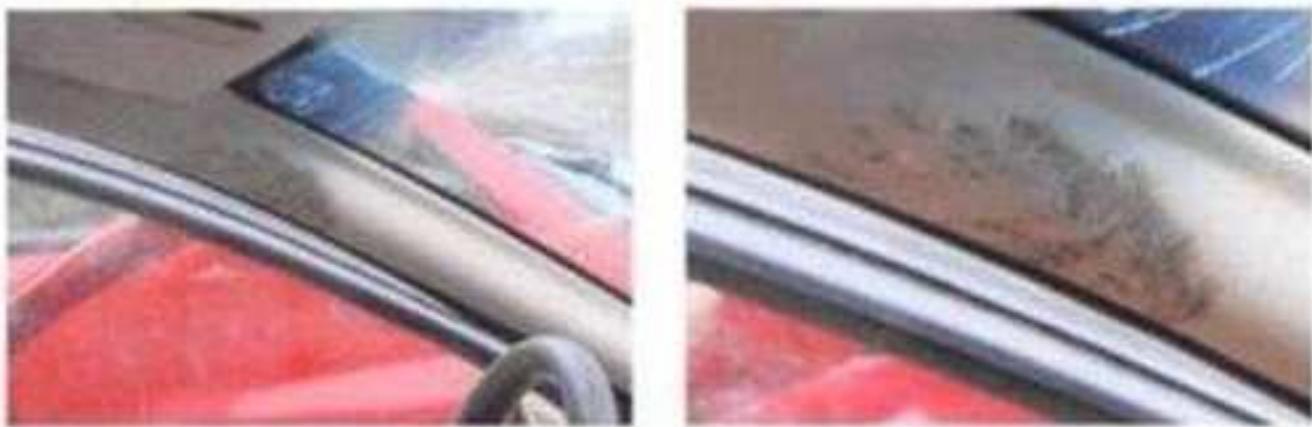
On the 'A' pillar post and adjacent to the stellar break to the windshield, a brown or blackish type smear is evident which almost has the same visual color as the print on the driver's door interior armrest. To the naked eye, it gives the basic impression of possibly a left hand print versus a right with three extended digits pointing towards the roofline. However, again, a specialized technical examination of this mark would need to be conducted by other persons.

Two areas of blackish/brownish smear were also located on the driver's side 'A' pillar post adjacent to the stellar break and the second smear or print was located on the arm rest of the driver's door. Without additional specialized examination by qualified technicians, its source or any other foreign matter found within or upon the Saturn will be unknown.

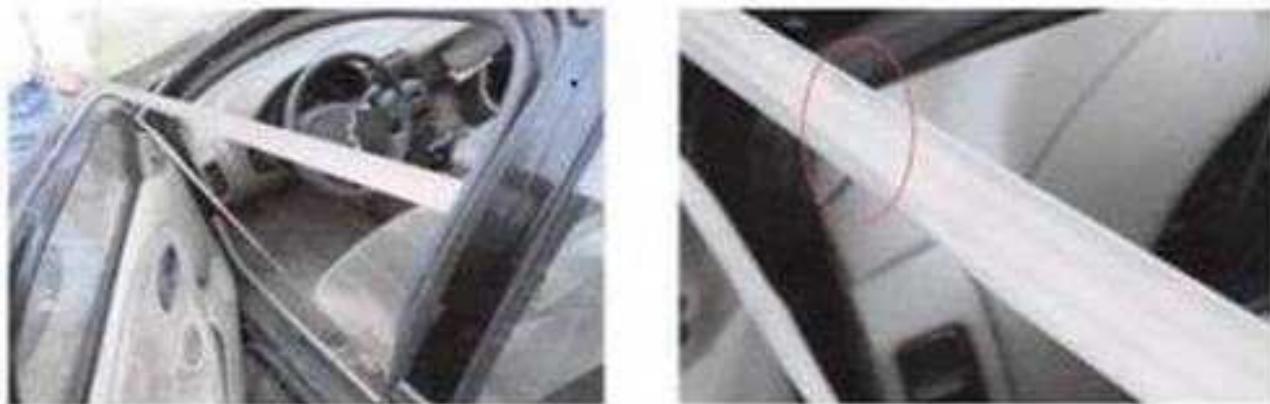
The seatbelts were of an active restraint system. The driver's belt did not show any signs of stress concentration marks, webbing elongation, deposits of foreign matter, and/or belt stiffening which would indicate the belt was worn at the time of impact. The SDM download also indicated the driver was 'unbelted' at the time of the collision. There was no reddish liquid aspersion consistent with what was located on the interior panels. The belt was warped in one location; consistent with hanging from the 'D' ring on the 'B' pillar post above the operator's head. This would be common for belts that were in the unsecured position over a period of time.

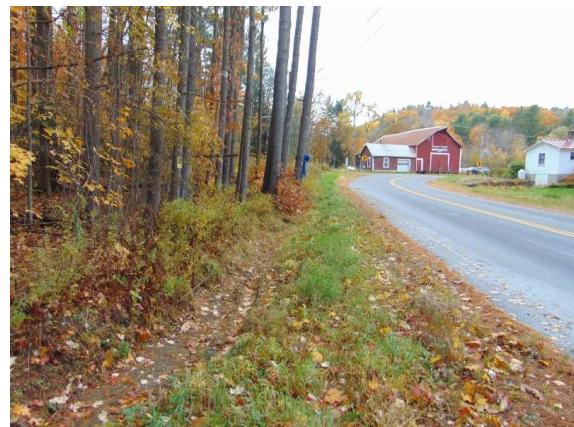
As it relates to what could have caused those two events to occur nearly simultaneously with a ‘Non-deployment’ occurring first; the edge of the roadway where Maura's Saturn was located contains a small ravine adjacent to a tree line. If the Saturn entered this ravine, it may have resulted in a ‘waking up’ of the SDM unit and recording a ‘Non-deployment’ event. The vehicle would then need to move \approx 1 foot to the tree line to result in the ‘Deployment’ event be commanded with airbag after having struck the tree line. If the front wheel assembly went into the ravine and/or struck the far side wall of the ravine adjacent to the treeline, the overhanging front end of the Saturn would now be closer to the base of either a tree or fixed object to result in a deployment command.

However, the damage is not consistent with striking a tree which has a perfectly vertical façade from the ground up. The damage is more consistent with a less acute angle of interaction between the two. If the front of the Saturn were down in the ravine, this would now change the horizontal pitch of the vehicle from a horizontal plane consistent with the pavement and place the front end of the vehicle more at an angle to the vertical façade of a tree. Or, if the angle of the tree were more of an acute angle as

shown in the photograph above with the blue ribbon, the angle to which these two engage could now be explained. This would allow the finite damage to the core fins to occur. However, the physical damage to the vehicle's hood and its configuration still are at question.

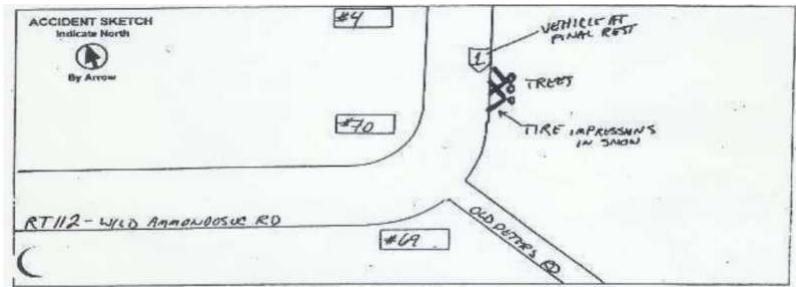
The damage associated with the collision is also on the driver's side. The Saturn would need to commence some sort of clockwise rotation before going off the roadway to have the driver's front corner leading the way to impact. This is consistent with the police diagram shown below where tell-tail signs of vehicle rotation are evident from the 'tire impressions' drawing.

In reference to the compass rose depicted in the diagram to the right¹, this vehicle is pictorially shown as facing in a southerly direction while situated along the northbound shoulder of the roadway; north of the aforementioned curve. The diagram depicts the vehicle as being on the edge of the roadway, but could it have also been slightly into the gully? There were no photographs taken of the scene and or any trees that may have been struck.

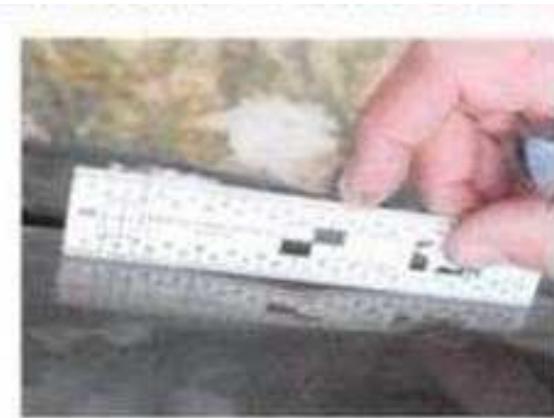
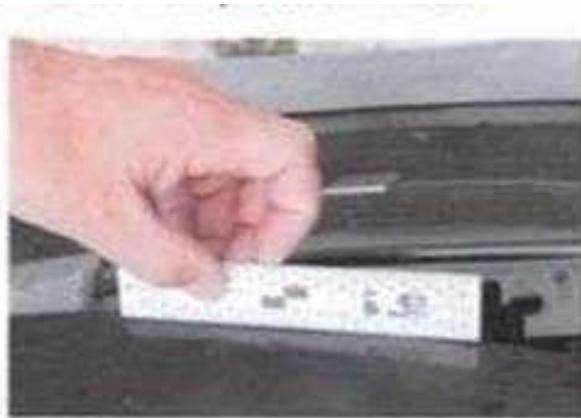
The other two impacts were minute in size and as compared to the damage noted above. These secondary dents did not contain any fractures of the paint and/or contain any foreign material. One was located to the passenger's side while the second one was located in the middle of the hood. The depth of both indents was so minuscule, measurement was difficult if not impossible to measure.

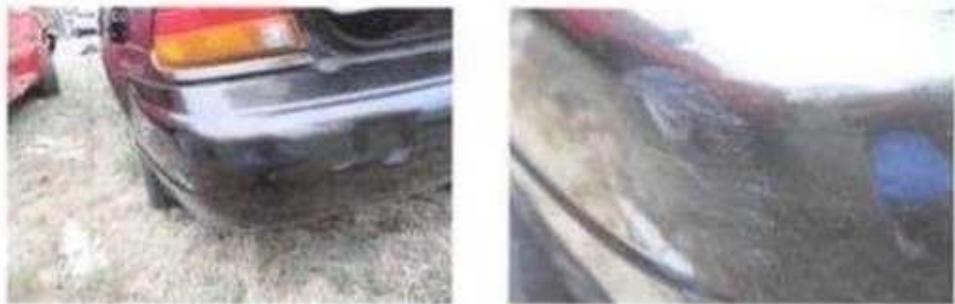
On the rear bumper several superficial marks were observed. These marks were whitish in color with horizontal striations on the driver's side rear corner. It is unknown as to whether these marks are related to this case or were the result of an early incident.

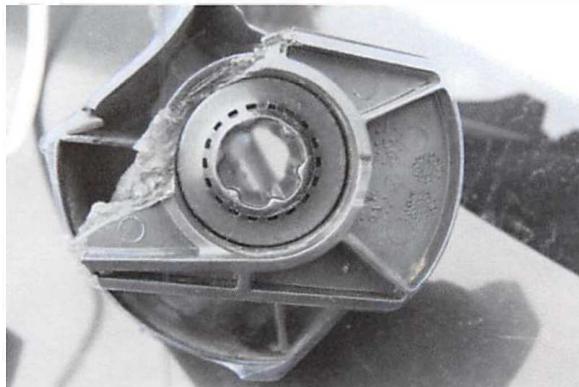
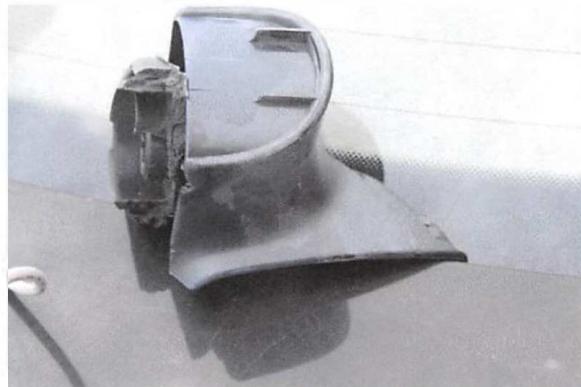
Within the vehicle, two automotive parts were observed. One was a broken part which had a round connecting port with a metal retaining ring. The part also contained a 'Chrysler' logo embossed on a flat portion. We could not locate any type of reference or part number.

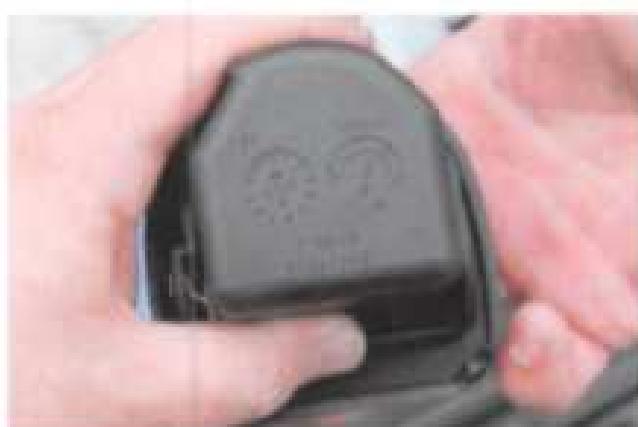
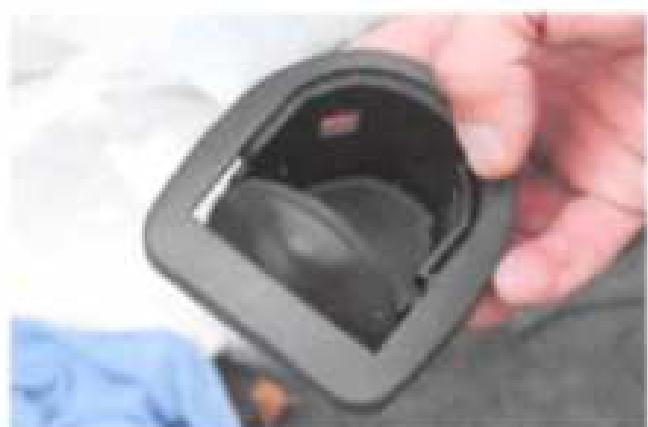
The second part was undamaged and appeared to be a type of coin holder with lid. Part number 21041748 was embossed on the back with other date. There was no automotive manufacturing symbol.

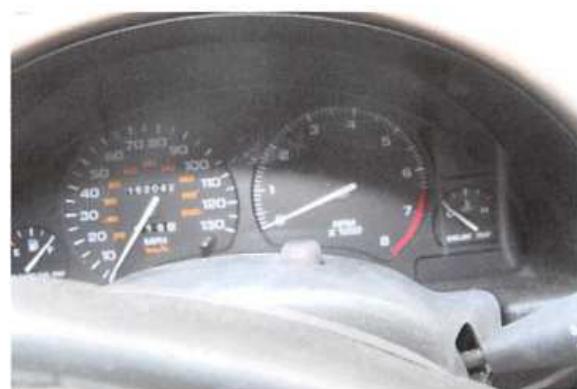
On an examination of the engine compartment, we found the oil level, transmission and brake reservoir contained adequate lubrication. The trunk of the vehicle had several full quarts of SAE 10 W20 motor oil in a case which originally contained approximately 12 bottles. A bottle of windshield fluid was also evident. The battery was dead but still connected and the fuel gauge indicated a full tank.

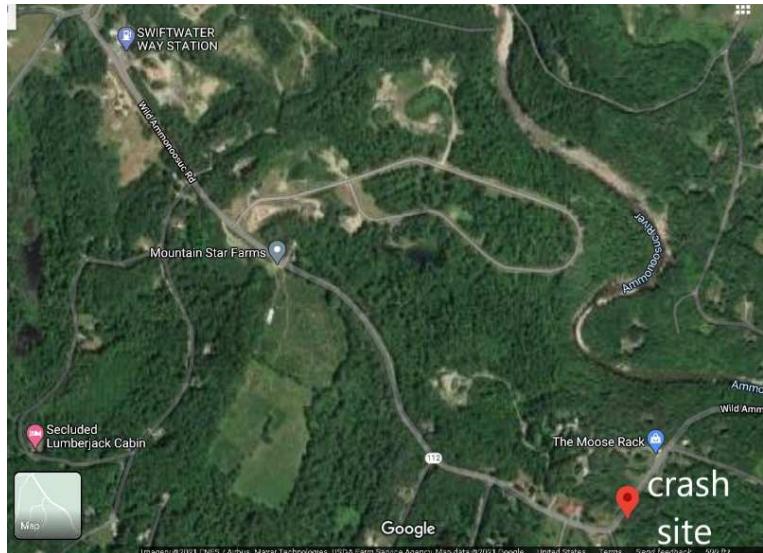
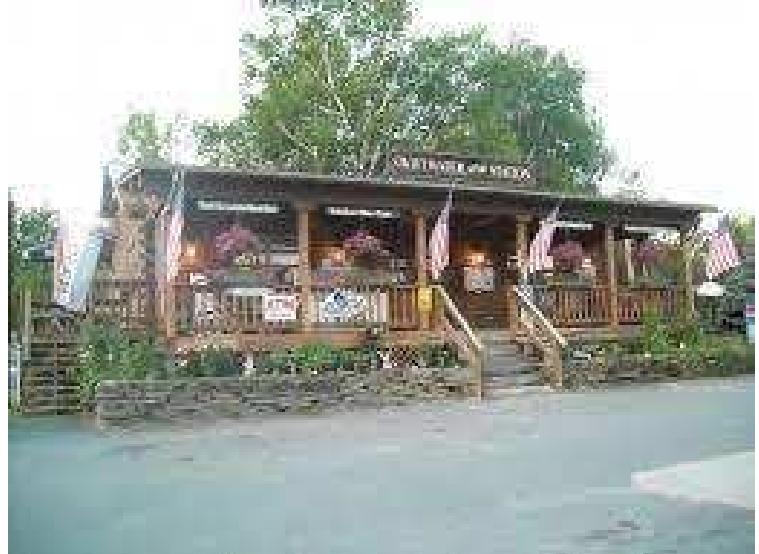
Swiftwater Way Station

Approximately 9/10th of a mile to the west of the collision, a small convenience store/gas station is located along the westbound shoulder. As aforementioned, the fuel gauge showed that the tank was full. If Maura were traveling south/east on Rte 112 (Wild Ammonoosuc Road) prior to the curve in the roadway, she would have passed the 'Swiftwater Way Station'. If Maura pulled into this location to fuel, she would need to go into the building to pay; as the pumps were of an older style and did not accept any type of credit/debit payment.
