Collision Synopsis

For Parkka Collision Consultants, Inc.

Daniel James Parkka
Actar 760 / Collision Reconstructionist

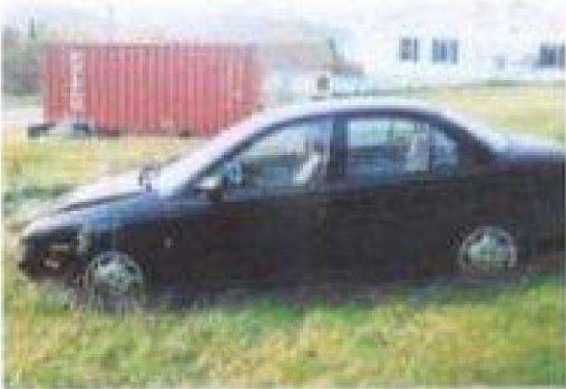
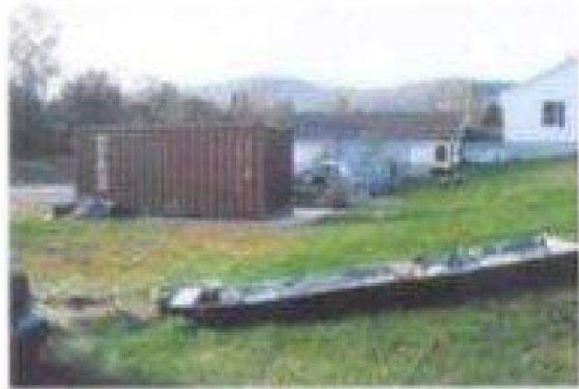
Possibly 2007 photographs based on computer file property

The Saturn apparently had been moved over the years from its location out in the far field as shown in the photograph below to a location adjacent to a storage bin. As shown in the photographs below, there is cross transfer of evidence pertaining to a dirt imprint on the passenger's front tire. The cross transfer would have developed when the Saturn was at rest in the field over an extended period of time before being moved. Simply moving the Saturn, now developed further damage to the front bumper which was evident.

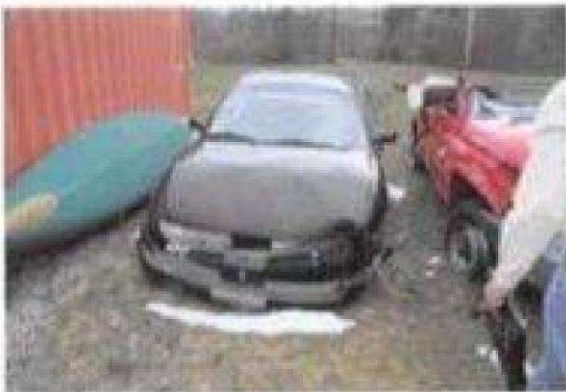
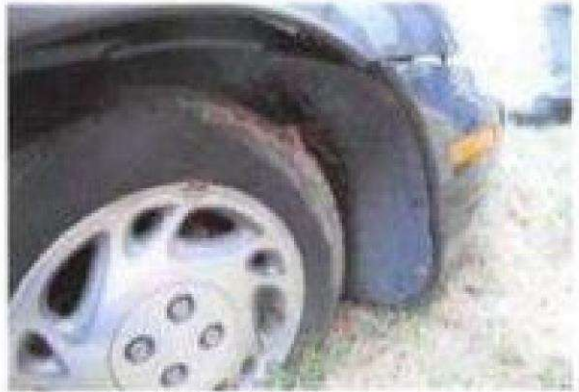
May 1, 2010 during vehicle inspection

On examination of the Saturn in 2010, the general vehicle was in poor condition exclusive of the damage sustained as a result of a collision. It appeared to be in a far better state back in 2007 as shown in photographs. The deterioration would more likely than not be a result of weather over the years and/or moving the vehicle throughout the back field of the NHSP barracks. The Saturn was not in a secured, sheltered environment. The vehicle had passed a yearly safety inspection evident by an inspection sticker affixed to the front windshield, expiring in October 2004 and had

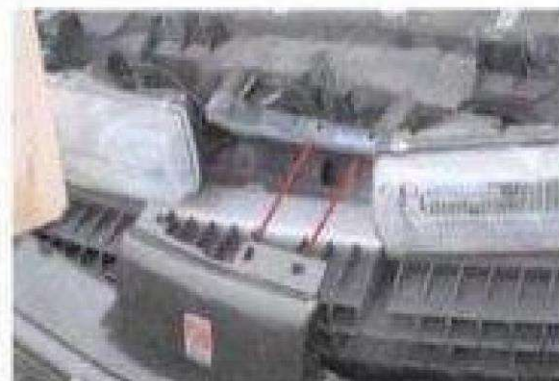
*Center bumper cover fasteners removed
Red arrows depict origin*

The driver's side inner core was pushed somewhat inward as compared to the passenger's side. The core also showed little damage with a few of the core vents slightly bent. There was also evidence of some abrasion to their outer façade. The mechanism which caused the bending to the core vents cannot be positively be classified as having solely occurred at the locus, as the Saturn has been moved at least once in the field behind the barracks. It is unknown as to whether the moving of the Saturn has caused additional damage to the inner core.

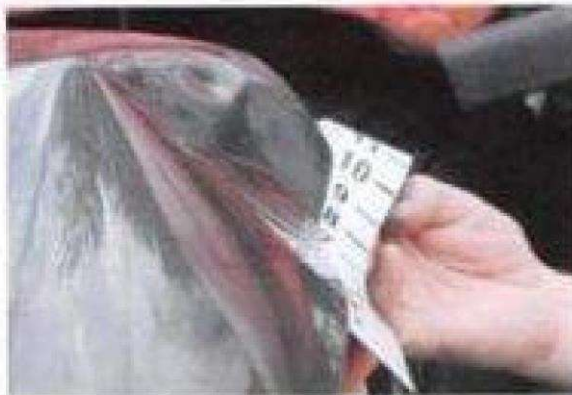
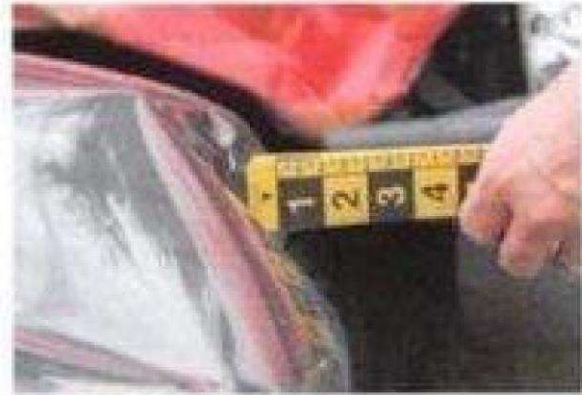
If the displacement of the core and the damage to the fins was the result of the initial impact in 2004, the intruding object would now need to extend down across the front bumper. However the façade of the intruding object could not have a perfectly vertical façade if it relates to the Saturn's approach. The core is still not pushed back to the extent of the hood damage to justify a perfectly vertical façade, nor does the hood dent have a perfectly vertical appearance, but rather an acute angled indent.

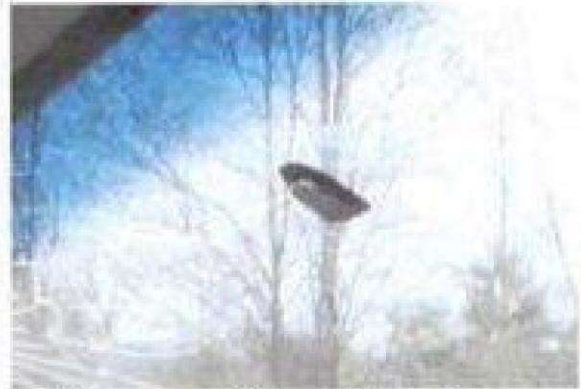
The interior mirror was missing with the supporting bracket still in place and did not show any sign of damage. In order to take the mirror off the windshield, it needs to be elevated towards the roofline and off the support. To attach the mirror, it needs to be slipped down onto the support and within a grooved channel. The mirror is then secured to the bracket by tightening an allen screw or nut fastener. If the allen screw were loose, the mirror could possibly be dislodged during contact with the operator as they are propelled towards the windshield during a frontal impact. This does not rule out the possibility that the mirror had been removed by police personnel for analysis and/or was initially missing prior to the incident.

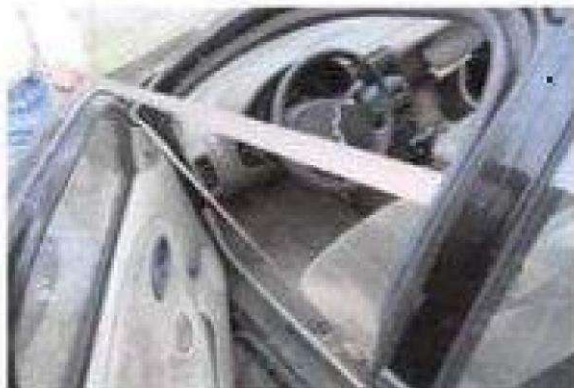
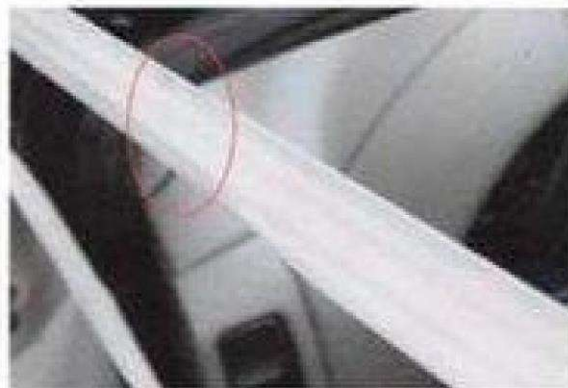
The seatbelts were of an active restraint system. The driver's belt did not show any signs of stress concentration marks, webbing elongation, deposits of foreign matter, and/or belt stiffening which would indicate the belt was worn at the time of impact. The SDM download also indicated the driver was 'unbelted' at the time of the collision. There was no reddish liquid aspersion consistent with what was located on the interior panels. The belt was warped in one location; consistent with hanging from the 'D' ring on the 'B' pillar post above the operator's head. This would be common for belts that were in the unsecured position over a period of time.

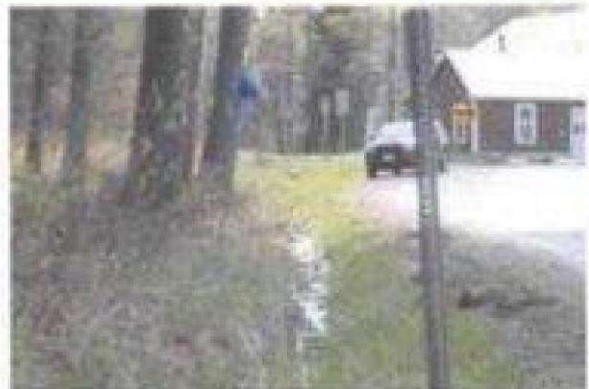
As it relates to what could have caused these two events to occur nearly simultaneously with a 'Non-deployment' occurring first; the edge of the roadway where Maura's Saturn was located contains a small ravine adjacent to a tree line. If the Saturn entered this ravine, it may have resulted in a 'waking up' of the SDM unit and recording a 'Non-deployment' event. The vehicle would then need to move \approx 1 foot to the tree line to result in the 'Deployment' event be commanded with airbag after having struck the tree line. If the front wheel assembly went into the ravine and/or struck the far side wall of the ravine adjacent to the tree line, the overhanging front end of the Saturn would now be closer to the base of either a tree or fixed object to result in a deployment command.

However, the damage is not consistent with striking a tree which has a perfectly vertical façade from the ground up. The damage is more consistent with a less acute angle of interaction between the two. If the front of the Saturn were down in the ravine, this would now change the horizontal pitch of the vehicle from a horizontal plain consistent with the pavement and place the front end of the vehicle more at an angle to the vertical façade of a tree. Or, if the angle of the tree were more of an acute angle as

shown in the photograph above with the blue ribbon, the angle to which these two engage could now be explained. This would allow the finite damage to the core fins to occur. However, the physical damage to the vehicle's hood and its configuration still are at question.

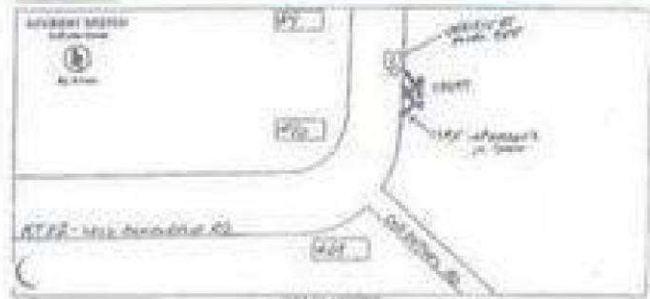
The damage associated with the collision is also on the driver's side. The Saturn would need to commence some sort of clockwise rotation before going off the roadway to have the driver's front corner leading the way to impact. This is consistent with the police diagram shown below where tell-tail signs of vehicle rotation are evident from the 'tire impressions' drawing.

In reference to the compass rose depicted in the diagram to the right¹, this vehicle is pictorially shown as facing in a southerly direction while situated along the northbound shoulder of the roadway; north of the aforementioned curve. The diagram depicts the vehicle as being on the edge of the roadway, but could it have also been slightly into the gully? There were no photographs taken of the scene and or any trees that may have been struck.

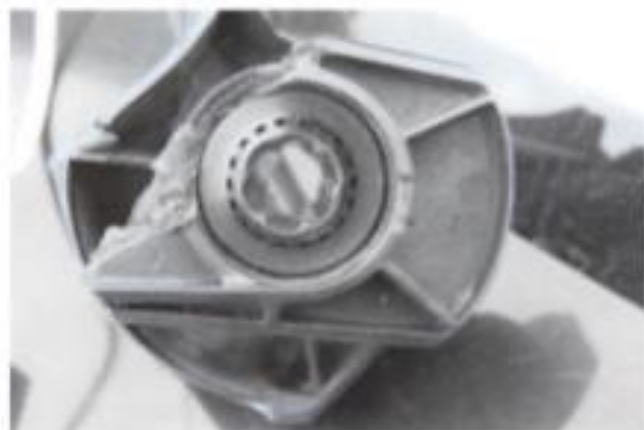
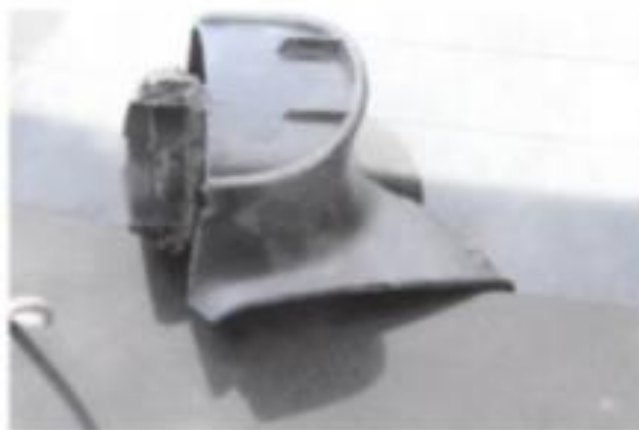
Within the vehicle, two automotive parts were observed. One was a broken part which had a round connecting port with a medal retaining ring. The part also contained a 'Chrysler' logo embossed on a flat portion. We could not locate any type of reference or part number.

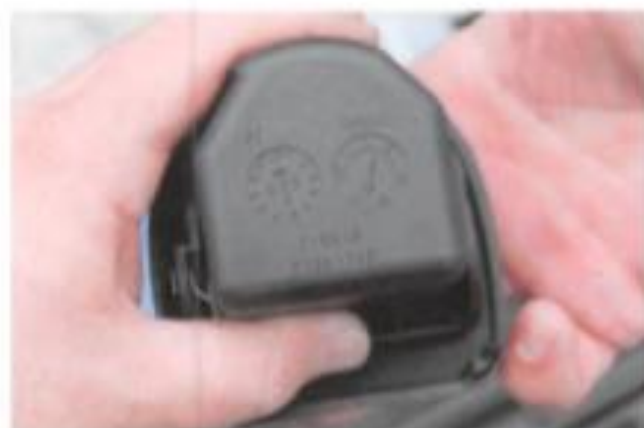
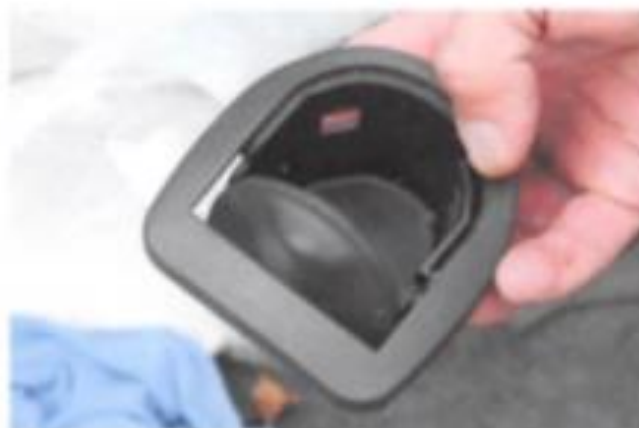
The second part was undamaged and appeared to be a type of coin holder with lid. Part number 21041748 was embossed on the back with other data. There was no automotive manufacturing symbol.

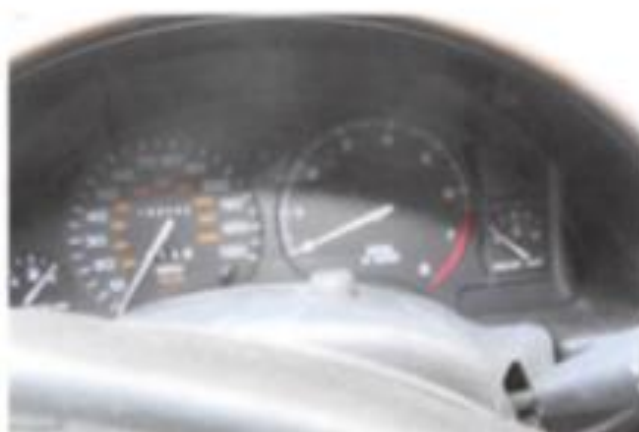
On an examination of the engine compartment, we found the oil level, transmission and brake reservoir contained adequate lubrication. The trunk of the vehicle had several full quarts of SAE 10 W20 motor oil in a case which originally contained approximately 12 bottles. A bottle of windshield fluid was also evident. The battery was dead but still connected and the fuel gauge indicated a full tank.
